Inspection Report

This report concerns the Dry Film Thickness readings taken on the Zinga coatings that were applied onto the steel beams during the works being carried out below the pavement at 120 Oxford Street, Central London. The readings were taken by the contractor.

Date: 23-03-21	Your ref: John Butcher	Inspection date: 18-03-21	Account no: N/A	Ref: 21-057
-----------------------	-------------------------------	----------------------------------	------------------------	--------------------

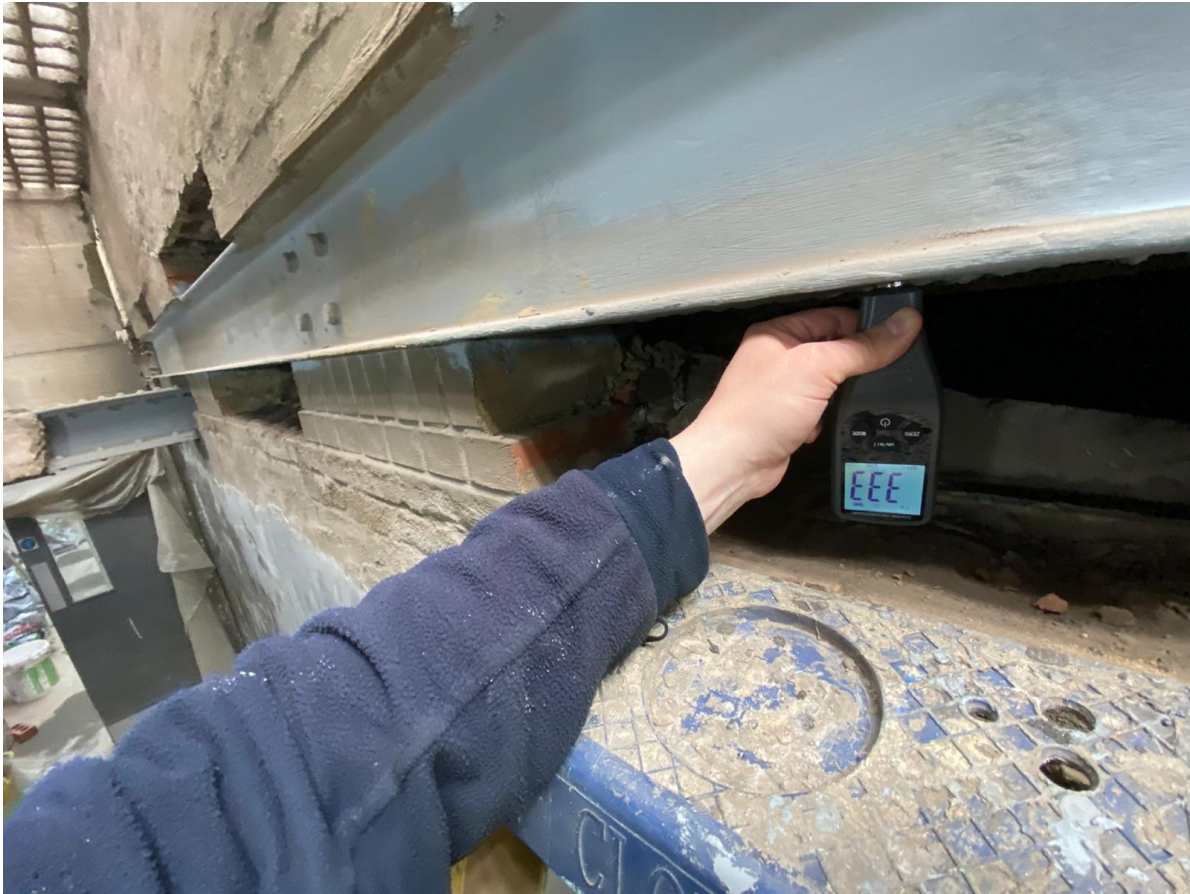
1. This reading shows 333 μ m DFT, and this is excessive. Where 180 μ m DFT has been specified, we work to SSPC-PA2 like thousands of other people in the industry, and the upper threshold limit that we work to is always 120% of the specified figure. In this case it is $180 \times 120\% = 216$ (220 rounded-up). This beam looks like a new installation, so without seeing the 'before' photos it looks very high.

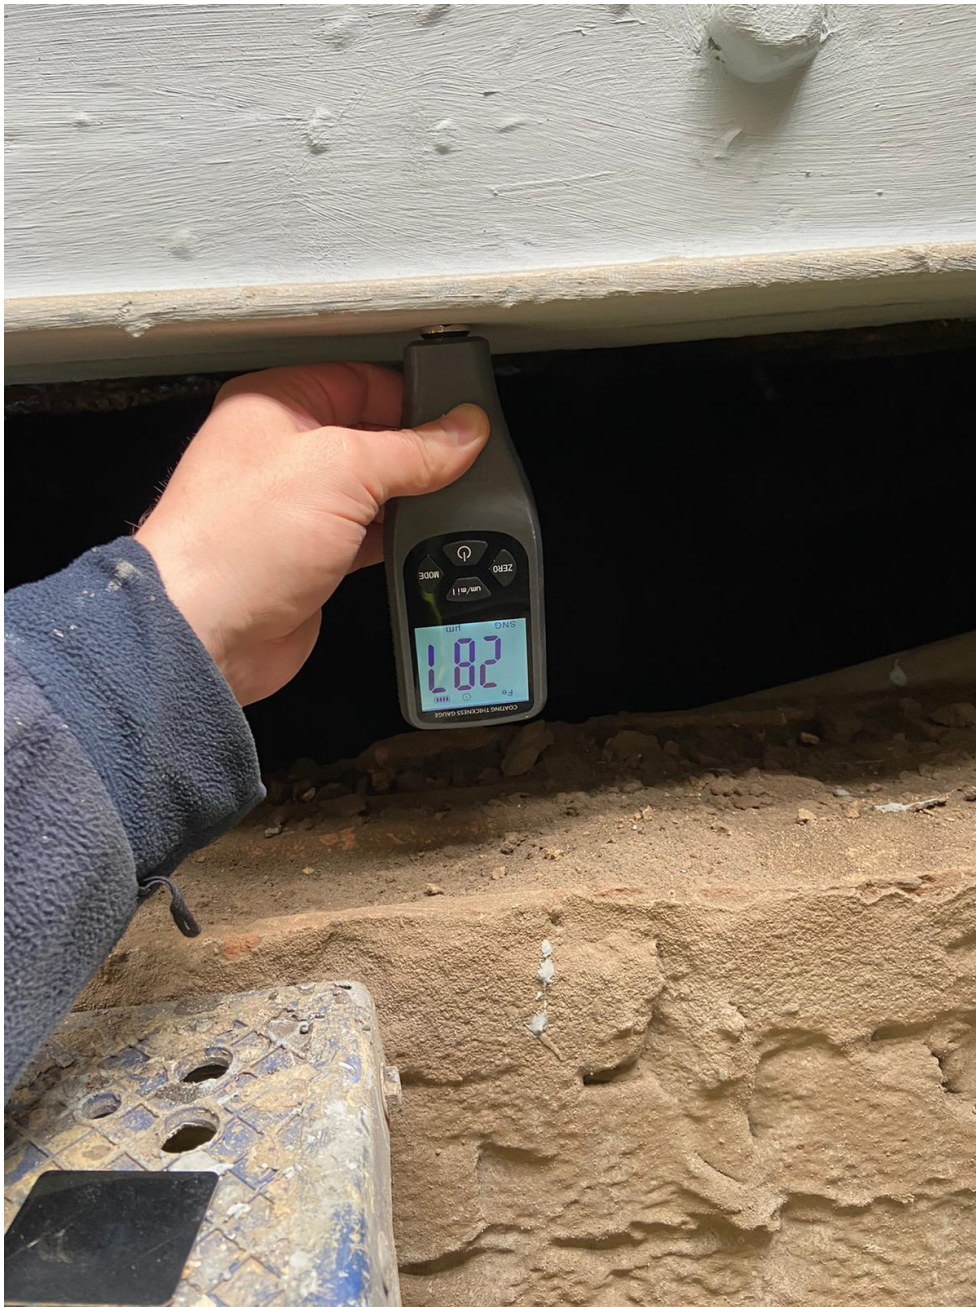
2. This figure of 287 μ m DFT could be a very high reading, or there could be surface undulations or 'scalloping' over a small area. This is the reason that coating inspectors take spot-readings ie three readings taken within the size of a hand. If two are showing, for example, 220 and one is showing 300 μ m DFT then the chances are that it is an erroneous reading.

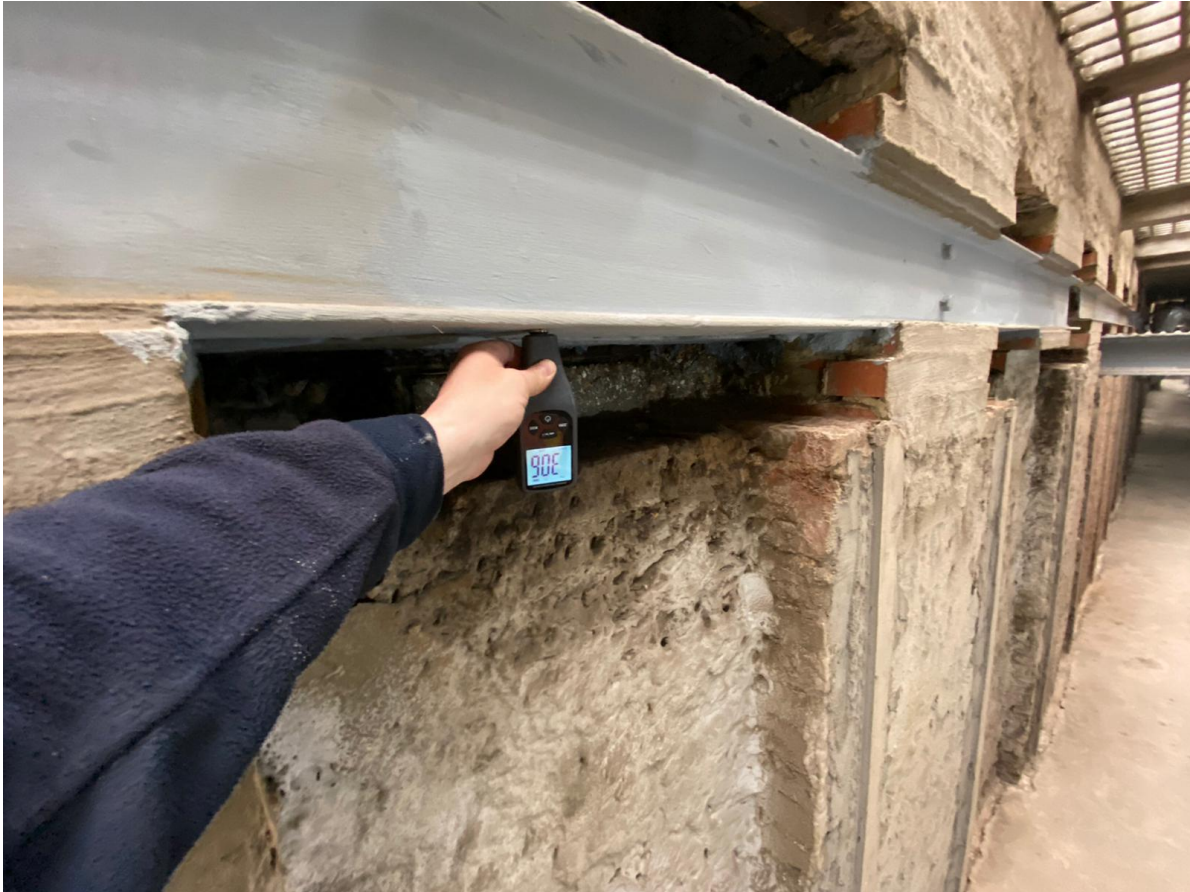
3. This reading is showing a value of 306 μ m DFT and the beam looks like a new one, so without any 'before' photographs we have to assume that the reading is very high. If it is a new beam with high readings, then the coating must be checked carefully for micro-cracking on inside corners where the film-build tends to be higher.

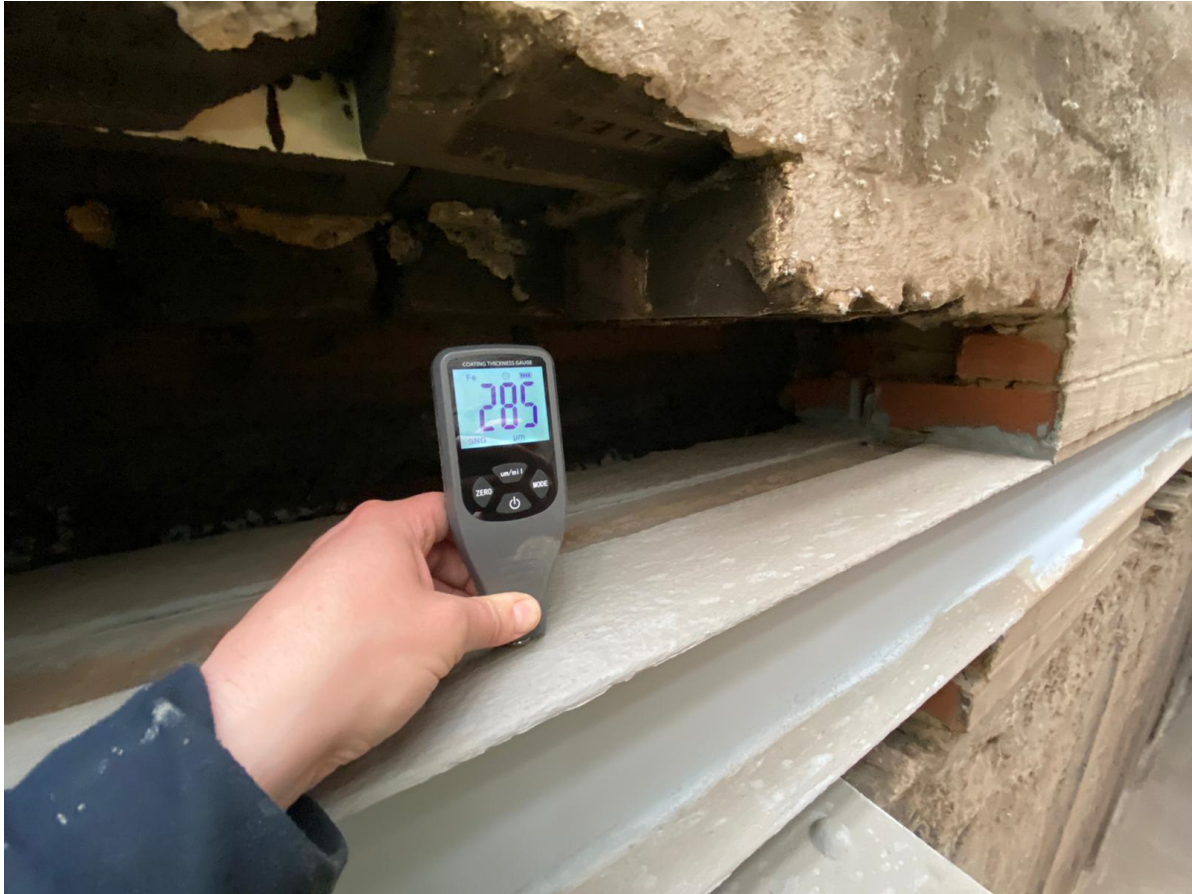
4. This reading is lower than the others but still very high.

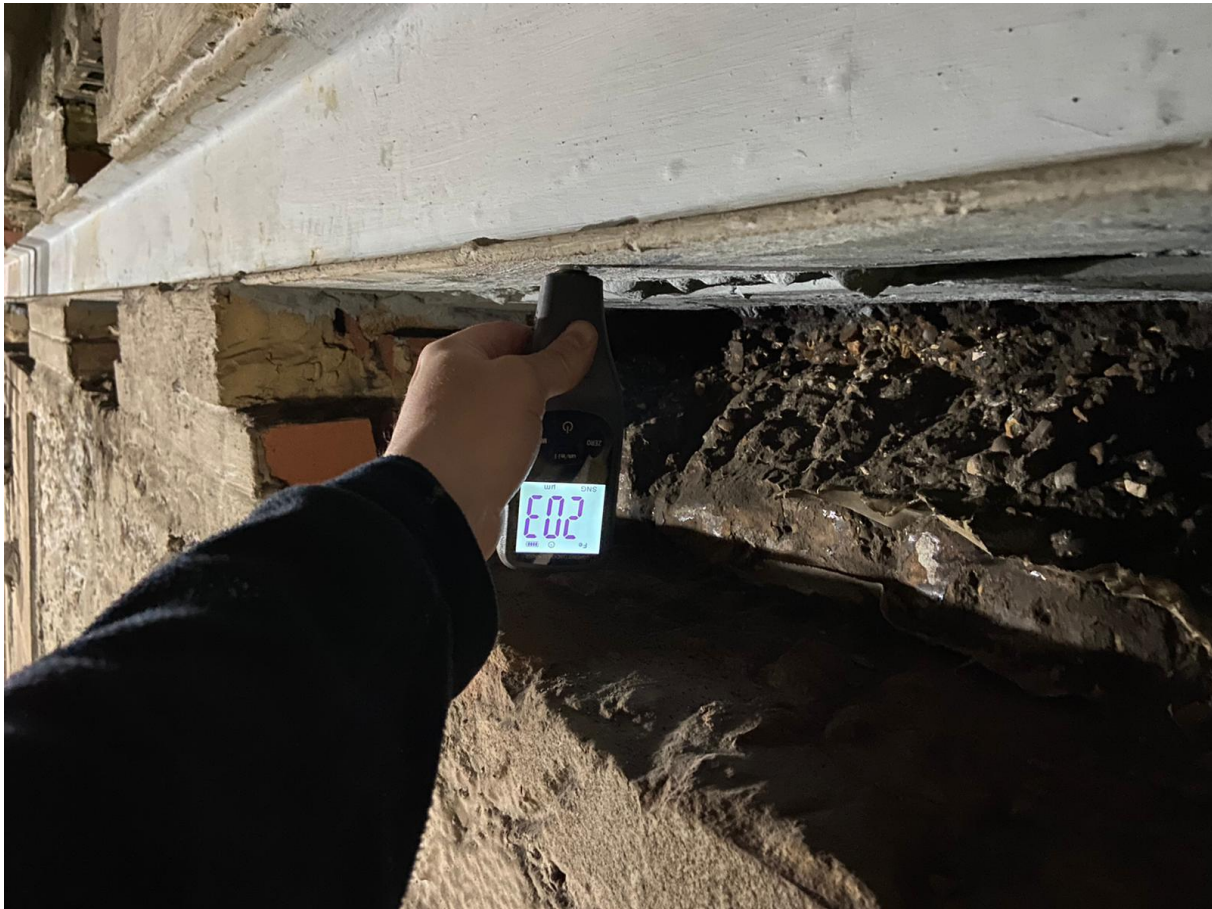
5. This reading is within the specified range.

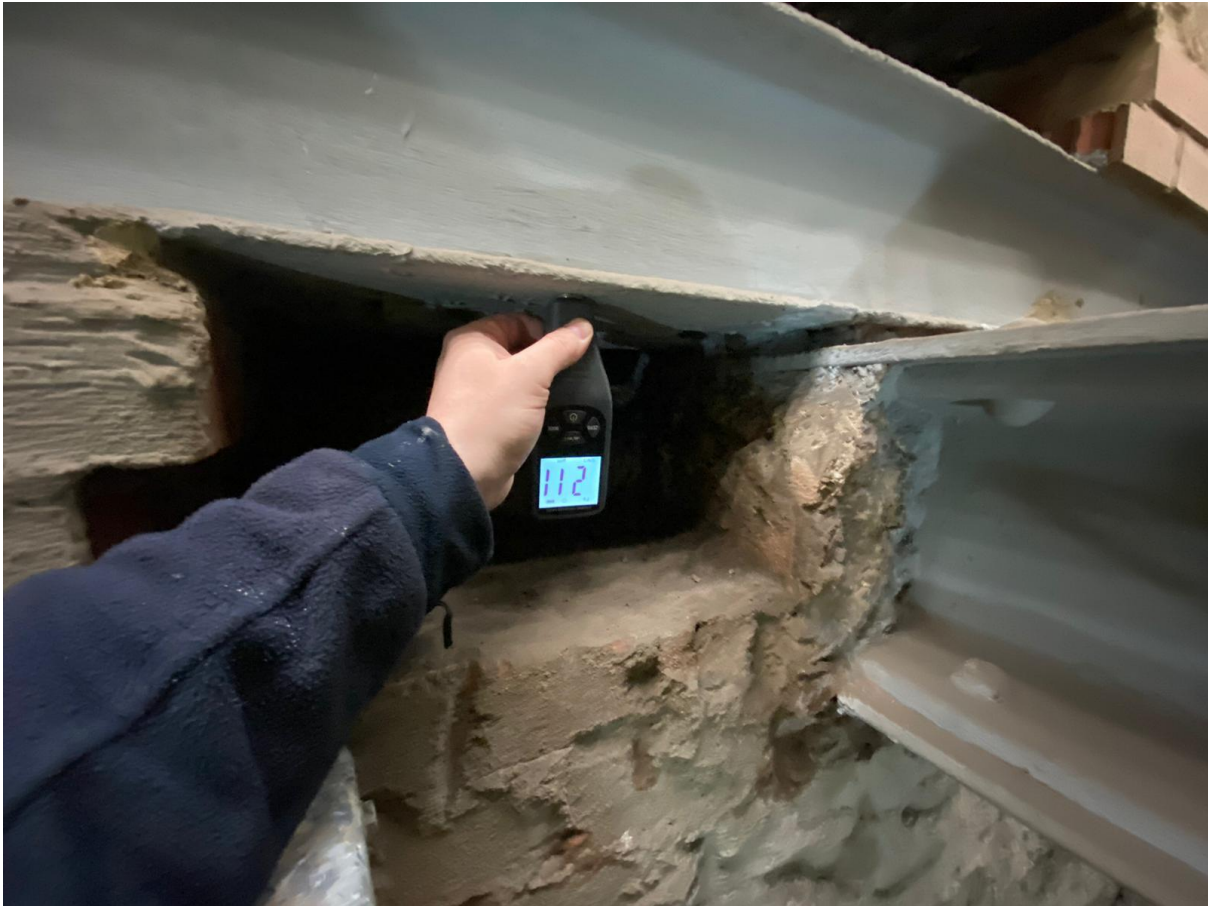
6. This reading is well within range.

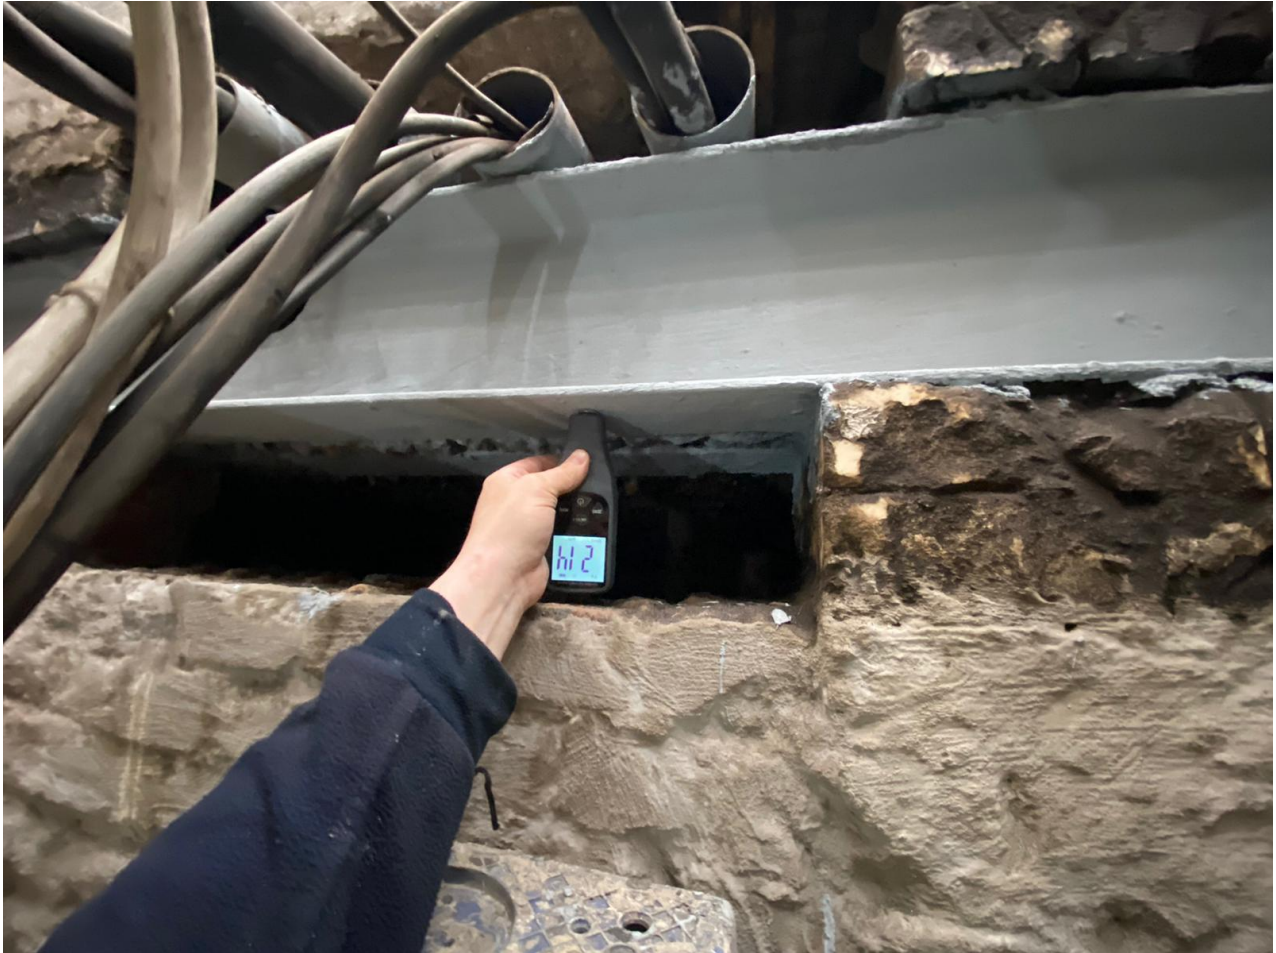
7. This reading is right on the threshold and so totally acceptable.

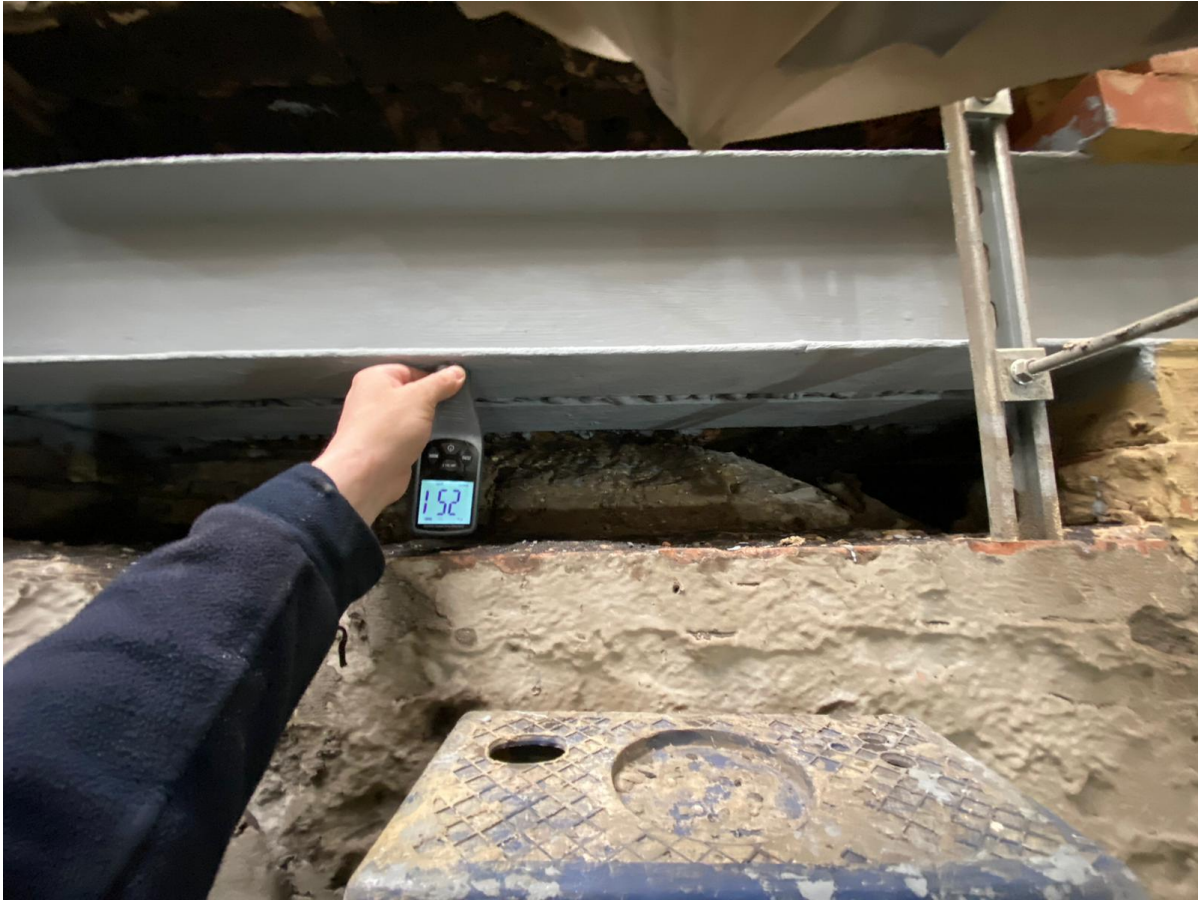
8. This reading was taken over an old beam, so surface corrosion defects could account for this high reading.
