## Free translation for GALVATOR<sup>®</sup> corrosion behavior

### AMIRKABIR UNIVERSITY POLY TECHNIC TEHRAN

#### 1- subject:

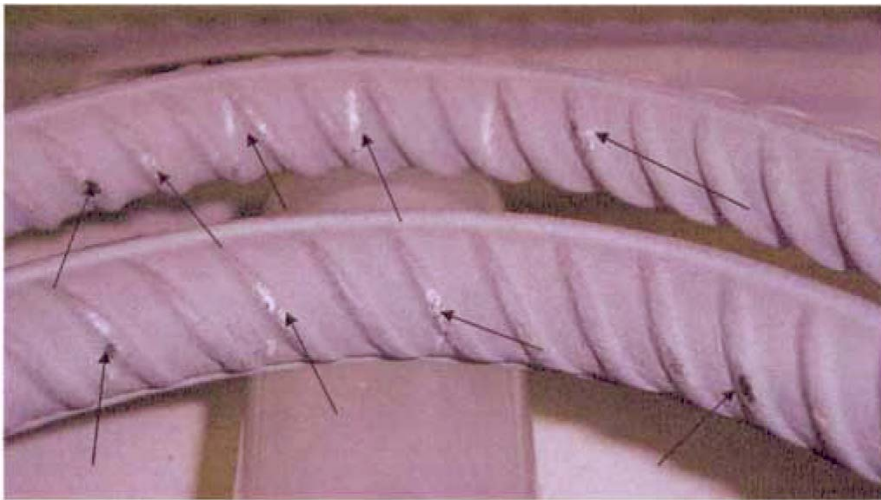
Figure (1)  
Scratched places made by bending tools

By inspecting carefully the bended GALVATOR<sup>®</sup> with magnifying lens, very small cracks were seen radiusly on the bending zone. But there was no detaching and peeling seen on the coating. Also at some places because of bending process the coating was scratched by the bending tools.

5-3- in places that the coating was damaged because of bending application, no traces of rust were not seen. This effect is obtained for the cathodic behavior of GALVATOR<sup>®</sup>.

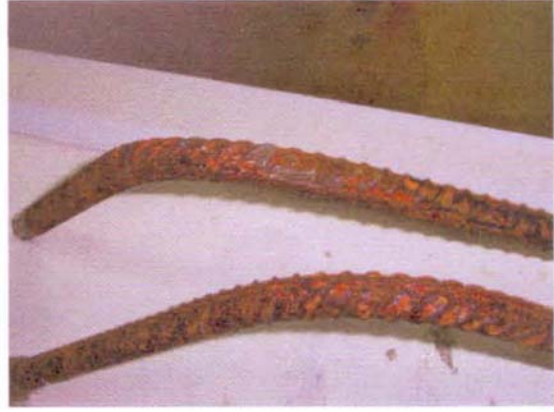
After 48 Hours from beginning of the test the carbon steel rebars rusted highly and for preventing the spreading of rust in the salt spray cabinet the carbon steel rebars were taken out.

Carbon steel Rebars after 48 hr. salt pray

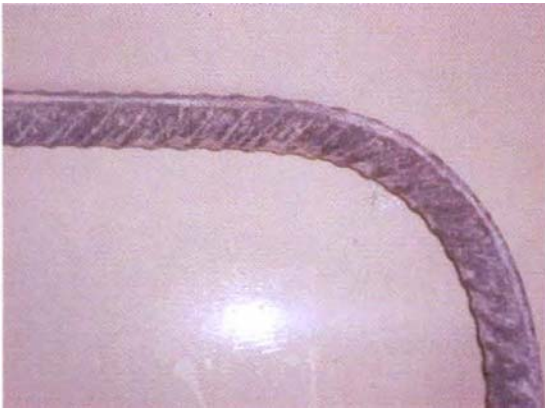
GALVATOR<sup>®</sup> after 48 hr. salt spray

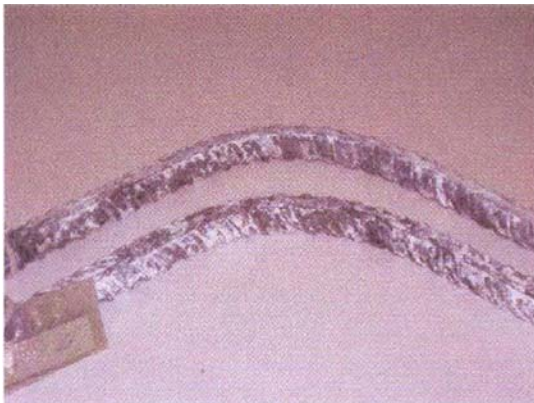
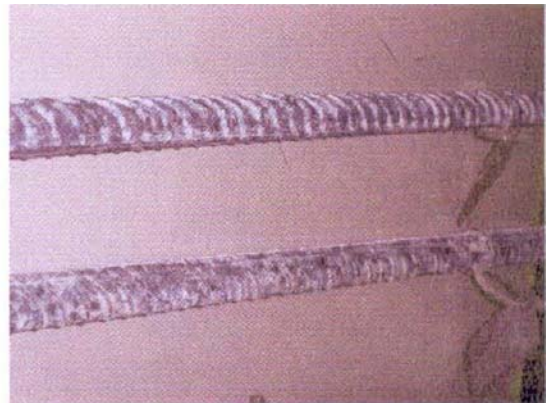
Figure 4  
300 hr. after salt spray

GALVATOR© after 300 hours salt spray

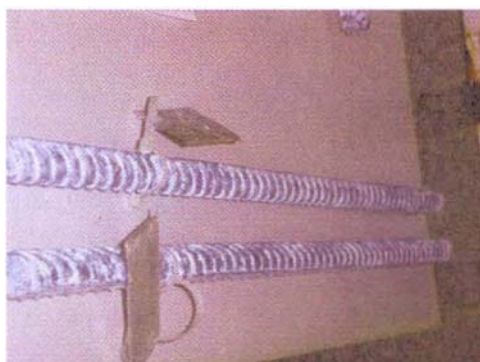
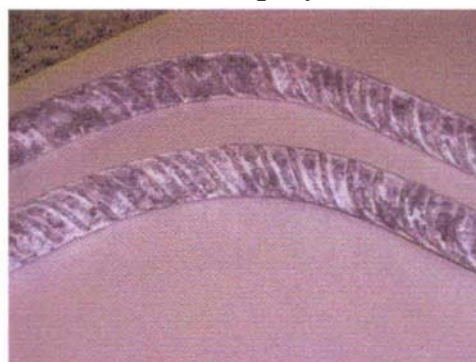
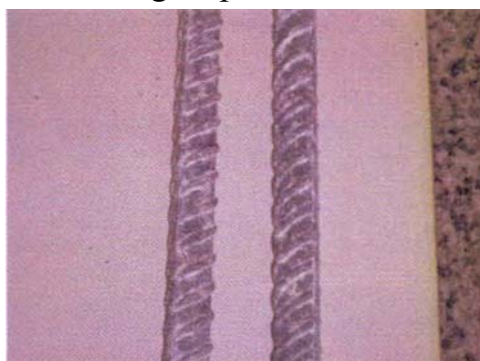
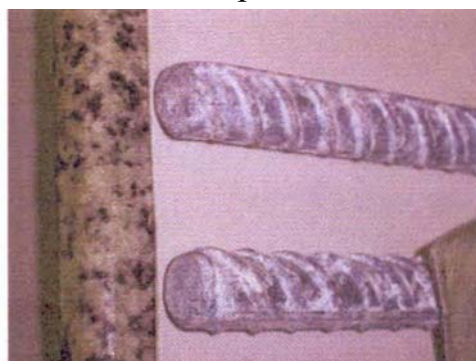
5-2- after 500 hours of salt spray test according to the ASTM D 610 and DIN 53210 standards there was no traces of rust seen on the surface of GALVATOR<sup>®</sup>. This illustrates the good resistance of GALVATOR<sup>®</sup> in corrosive environment.

5-4- at the end of the test, no traces of peeling, detaching and blistering were not seen according to ASTM D 714 and DIN 53209 on the surface of the coating. This illustrates the good adhesion of coating with steel substrate.

GALVATOR<sup>®</sup> after 500 Hours salt spray

GALVATOR<sup>®</sup> after 500 hr. salt spray

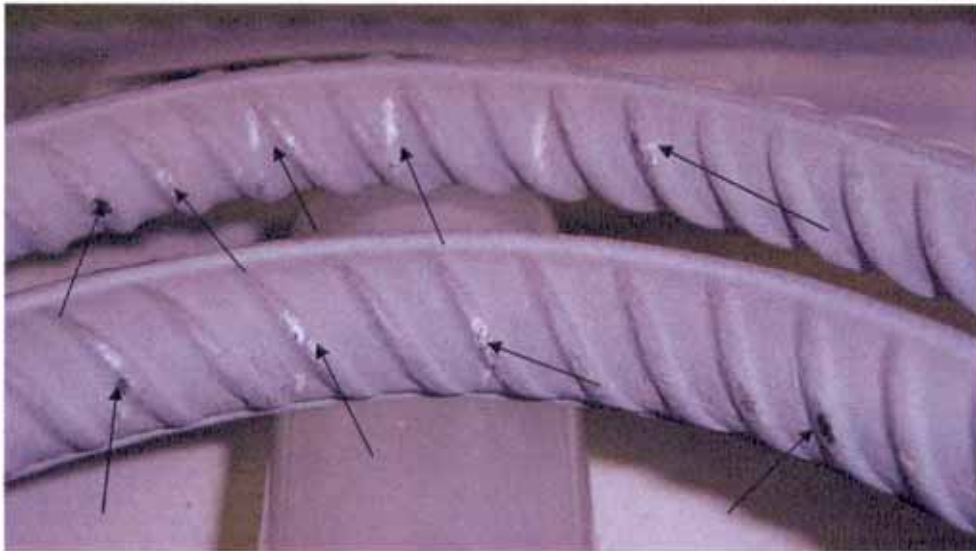
تصویر شماره (۱)  
محل‌های آسیب دیده بعلت عملیات خمکاری

با بررسی دقیق گالواتور خم شده با ذره‌بین مشاهده شد که در محل انحنای خم ترکهای بسیار ریزی بطور شعاعی بر روی میلگرد ایجاد شده است اما اثری از جدا شدن و طبله شدن پوشش بهیچ وجه مشاهده نگردید. ضمناً ملاحظه شد قسمتهایی از پوشش در اثر عملیات خمکاری با آچار زخمی شده است.

۳-۵- در محل هایی که پوشش در اثر خم کاری زخمی شده بود هیچگونه اثری از زنگ زدگی ملاحظه نشد. این ویژگی بعلافت قابلیت حفاظت کاتدی گالواتور تامین گردیده است.

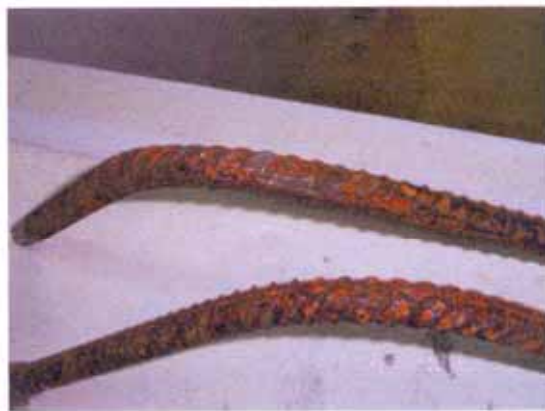
\* پس از گذشت ۴۸ ساعت از آغاز آزمایش میلگردهای کربن استیل بشدت مورد زنگ زدگی قرار گرفتند و بعلت جلوگیری از پخش شدن زنگ در دستگاه و آلوده ساختن سایر نمونه‌ها از دستگاه خارج گردیدند.

میلگردهای کربن استیل پس از گذشت ۴۸ ساعت

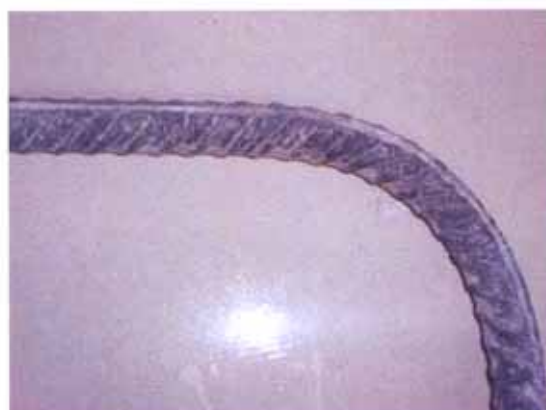
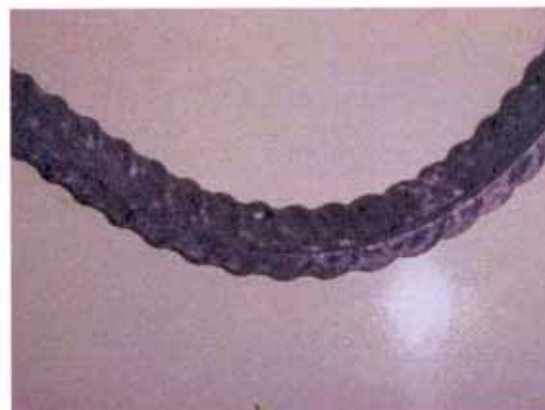
تصویر شماره (۳)

میلگرد گالواتور پس از گذشت ۴۸ ساعت از زمان آزمایش

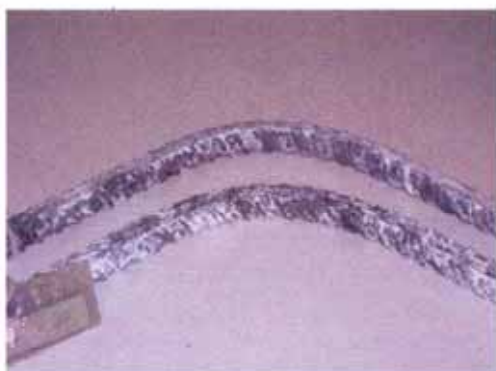
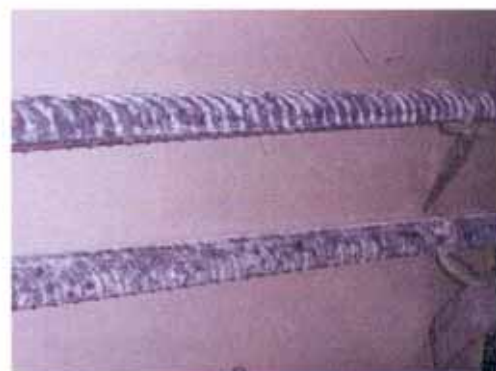
تصویر شماره (۴)  
۳۰۰ ساعت از گذشت آزمایش

نمونه های گالواتور پس از گذشت ۳۰۰ ساعت.

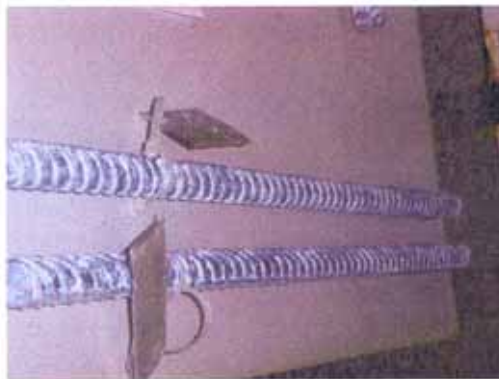
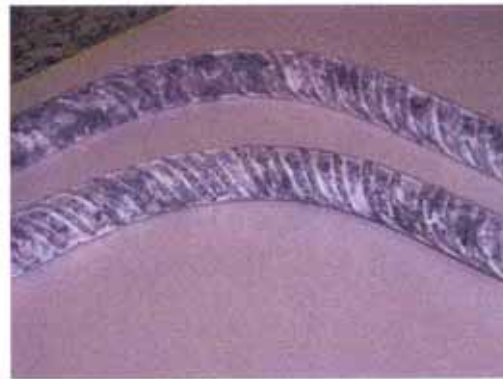
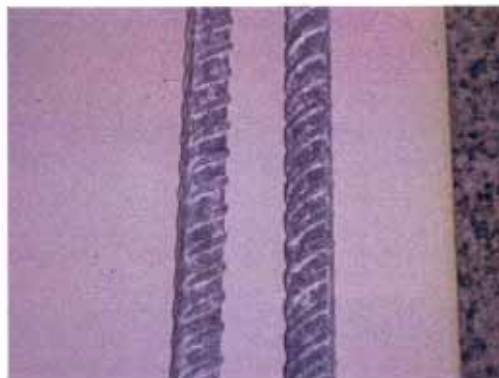
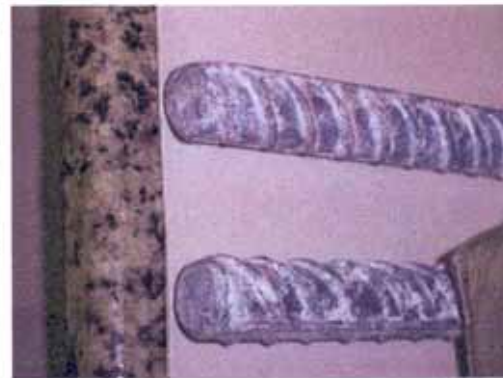
تصویر شماره (۵)

۲-۵- پس از گذشت بیش از ۵۰۰ ساعت از گذشت آزمایش هیچگونه اثری از زنگ زدگی (مطابق استانداردهای ASTM D 610 و DIN 53210) بر روی گالواتور مشاهده نگردید. این امر بیانگر عملکرد مطلوب این میلگرد در محیط خورنده می باشد.

۴-۵- پس از پایان آزمایش هیچگونه اثری از پلیسه شدن، طبله زدن و یا تاول زدگی مطابق استانداردهای (ASTM D 714 و DIN 53209) بر روی پوشش مشاهده نگردید. این بیانگر چسبندگی مطلوب پوشش با سطح فلز می باشد.

نمونه های گالوانور پس از گذشت ۵۰۰ ساعت
