DIRECTION DEPARTEMENTALE DE L'EQUIPEMENT, VENDEE SEA BUOYS – FRANCE

Subject: Test application Zinga on marine buoy in Noirmoutier.

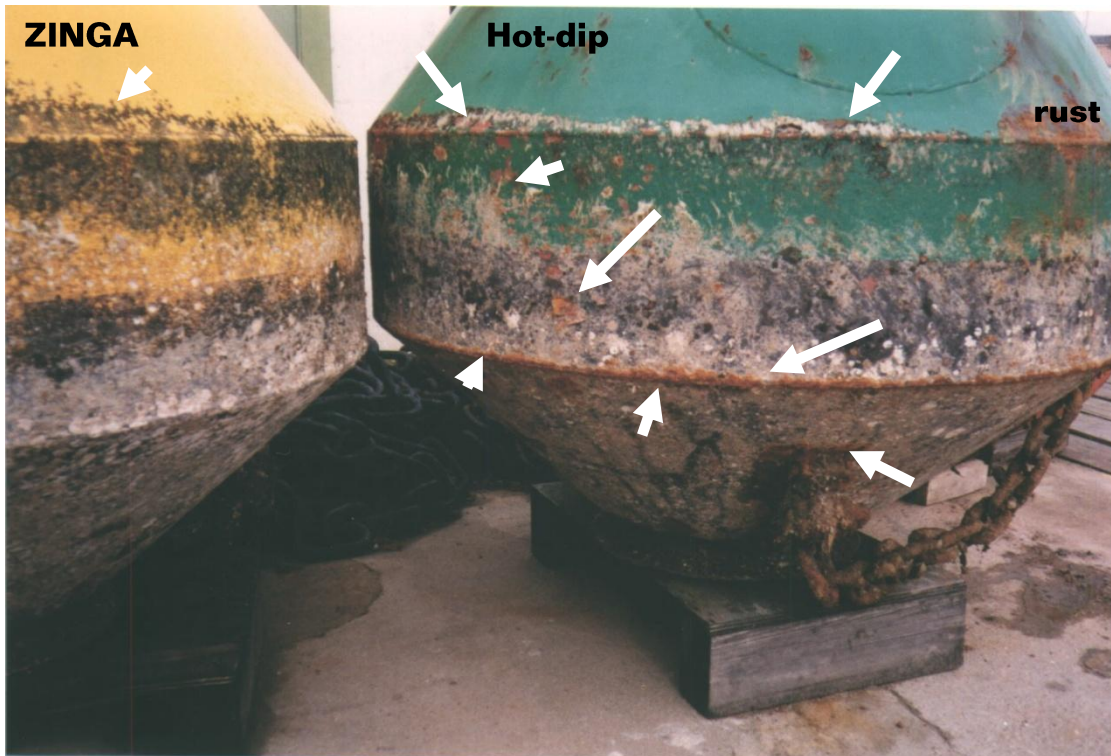
These two sea buoys have been floating in the Atlantic Ocean for 4 years. The yellow buoy, a mild steel buoy treated with Zinga, was compared to the green buoy that was galvanised by the traditional hot-dip process. The two buoys had received the same type of topcoats with the same layer thickness, with a supplementary adhesion coating for the hot-dipped buoy.

Conclusion of this test: the buoy treated with Zinga showed no trace of rust, but the hot-dip galvanised buoy was severely corroded in several places.
