PIPES – AUDI-VW – VORST – BELGIUM

In 2017 the **AUDI-VW** Car Company decided to repair their cold water piping located in their assembling unit of Vorst, Belgium, with **ZINGA** as stand-alone system.

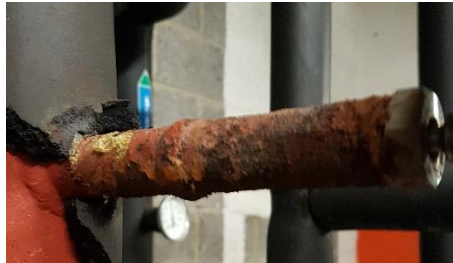
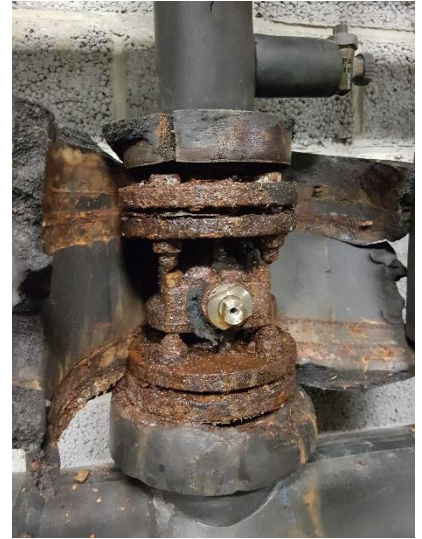
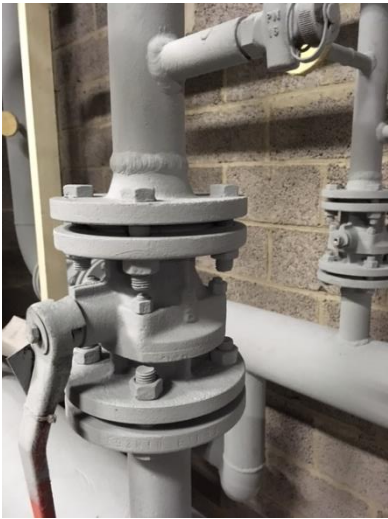
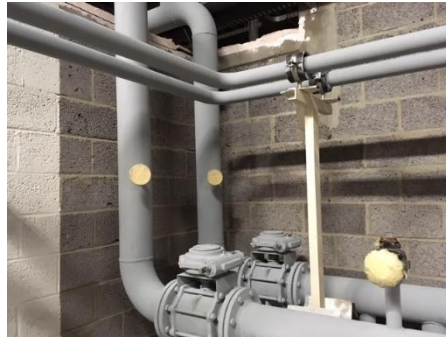
Before repairs with ZINGA

System:

Blasting with quartz to SA 2.5
ZINGA 2 x 60 µm DFT (brush)

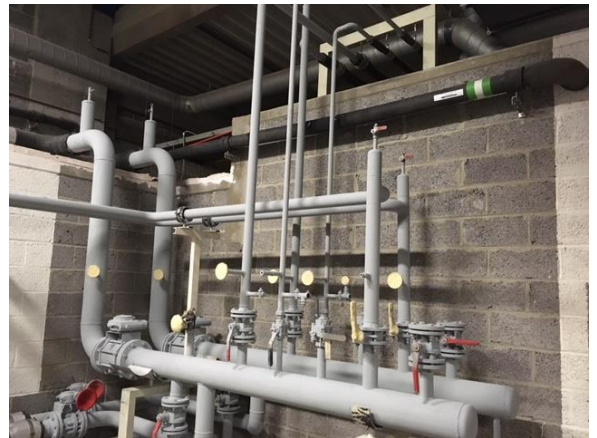
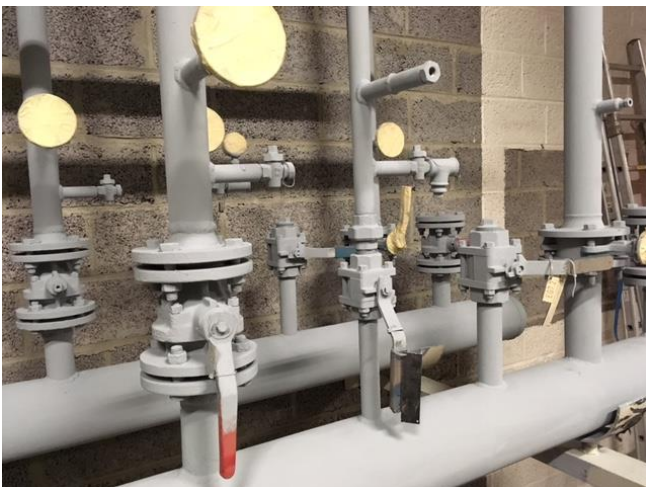
After repairs with ZINGA
