SUCCESS STORY OF ZINGA

INTERVENTION PERIOD :	From 30/05 to 05/08/2019
CONTRACTOR	ONEE Office National de l'Electricité et de l'eau
BUILDER	COVEC China Overseas Engineering Corporation
APPLICATION SUBSTRACT:	The supports of the solar panels
ATMOSPHERIC CONDITIONS:	Relative Humidity : 16 % à 17%, température: 35° à 45°C
PERMANENT TECHNICAL SUPPORT COMPANY:	LPEE: Laboratoire Public d'Essais et d'Etudes
TECHNICAL CONSULTANT:	M3C: Maroc Coating & Corrosion Consulting

b. Project data:

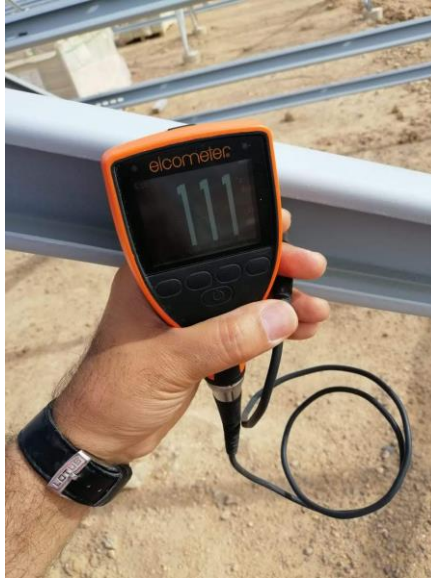
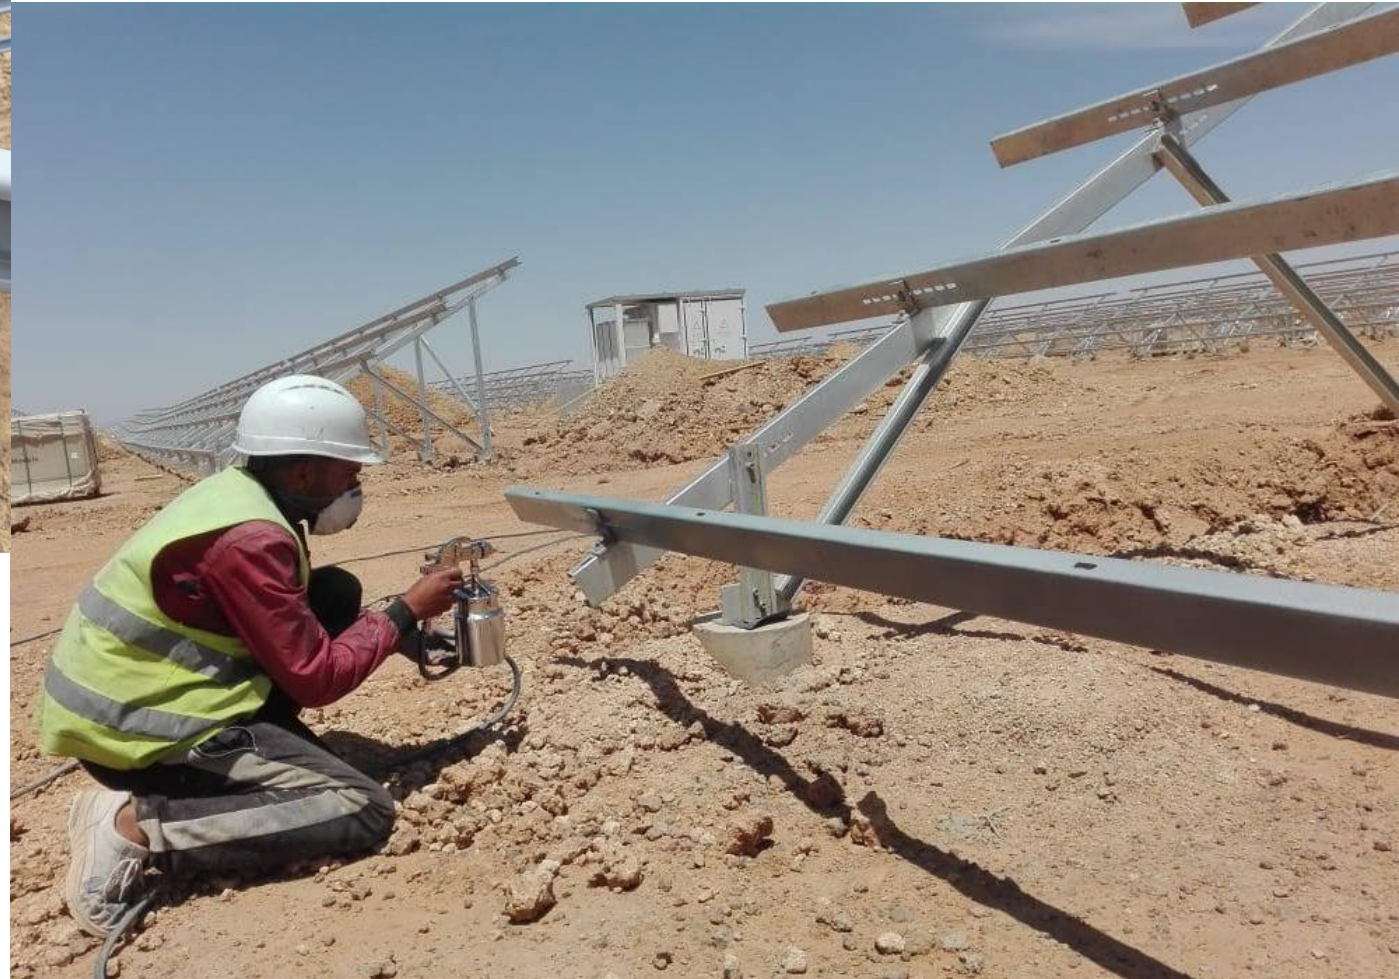
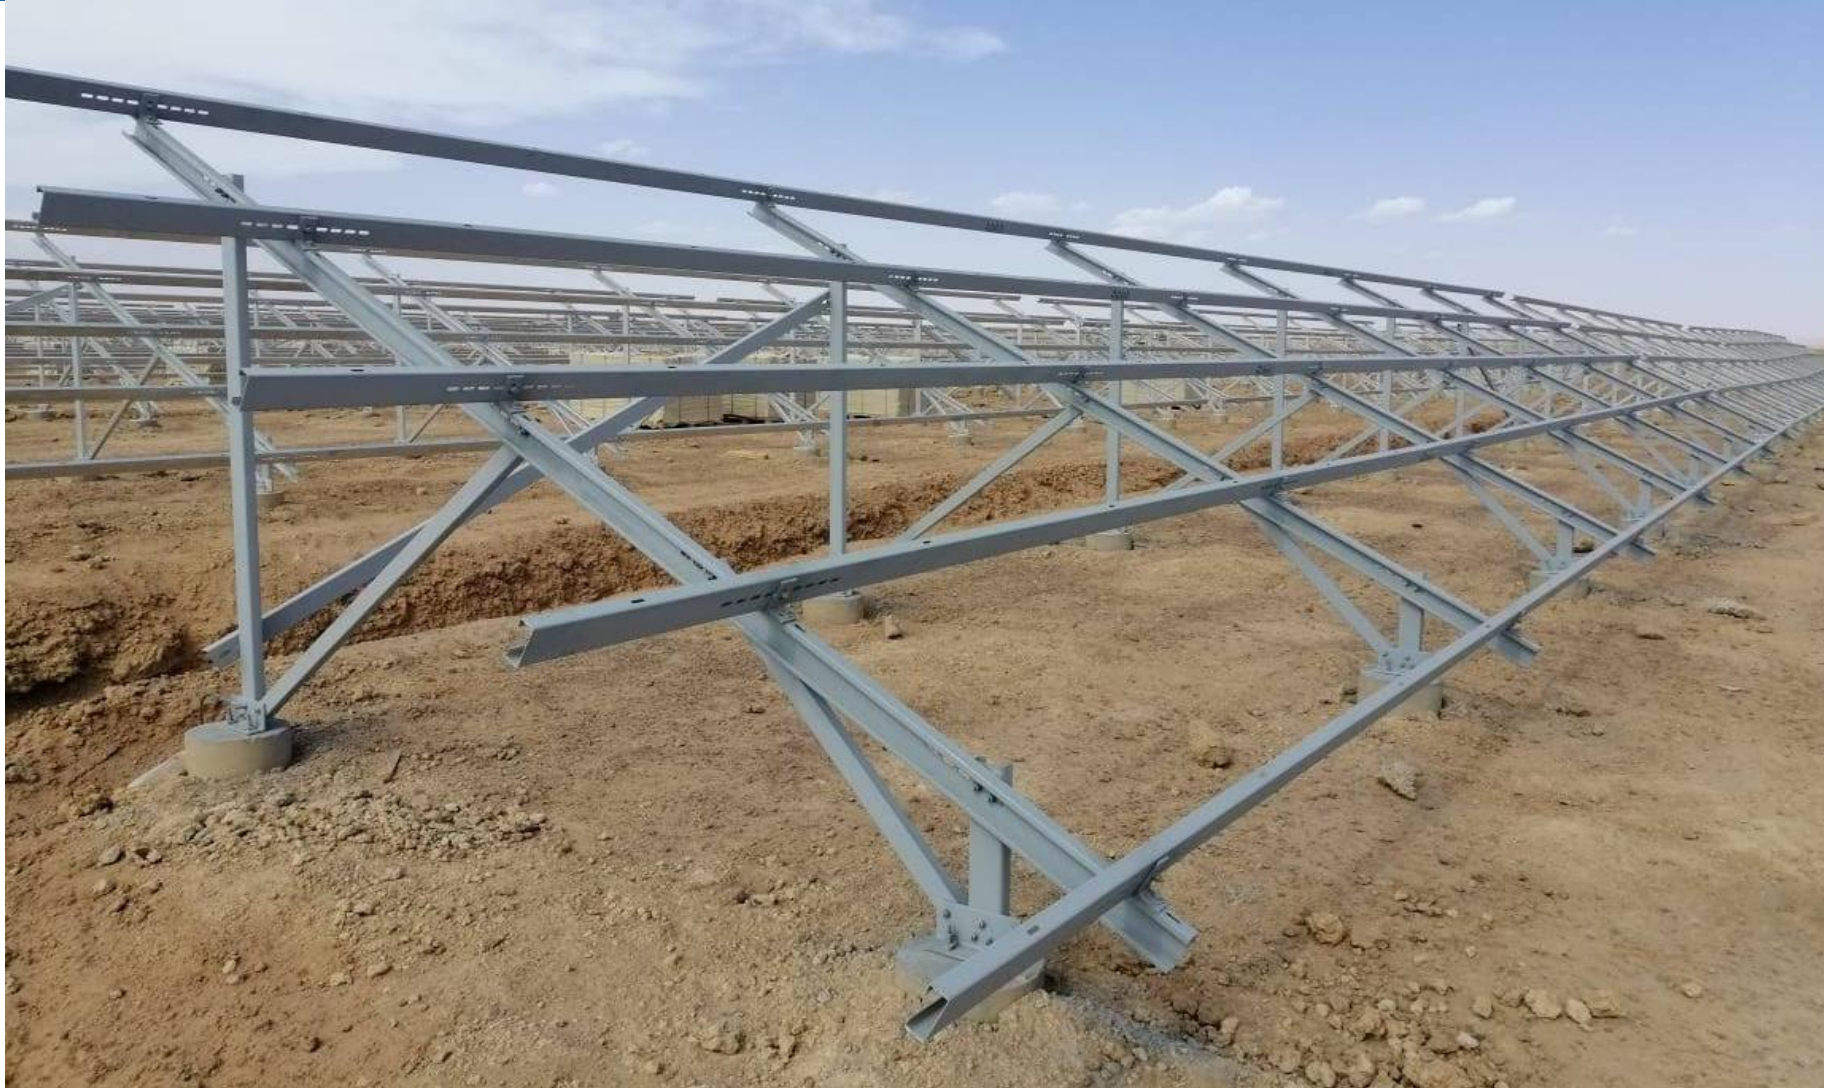
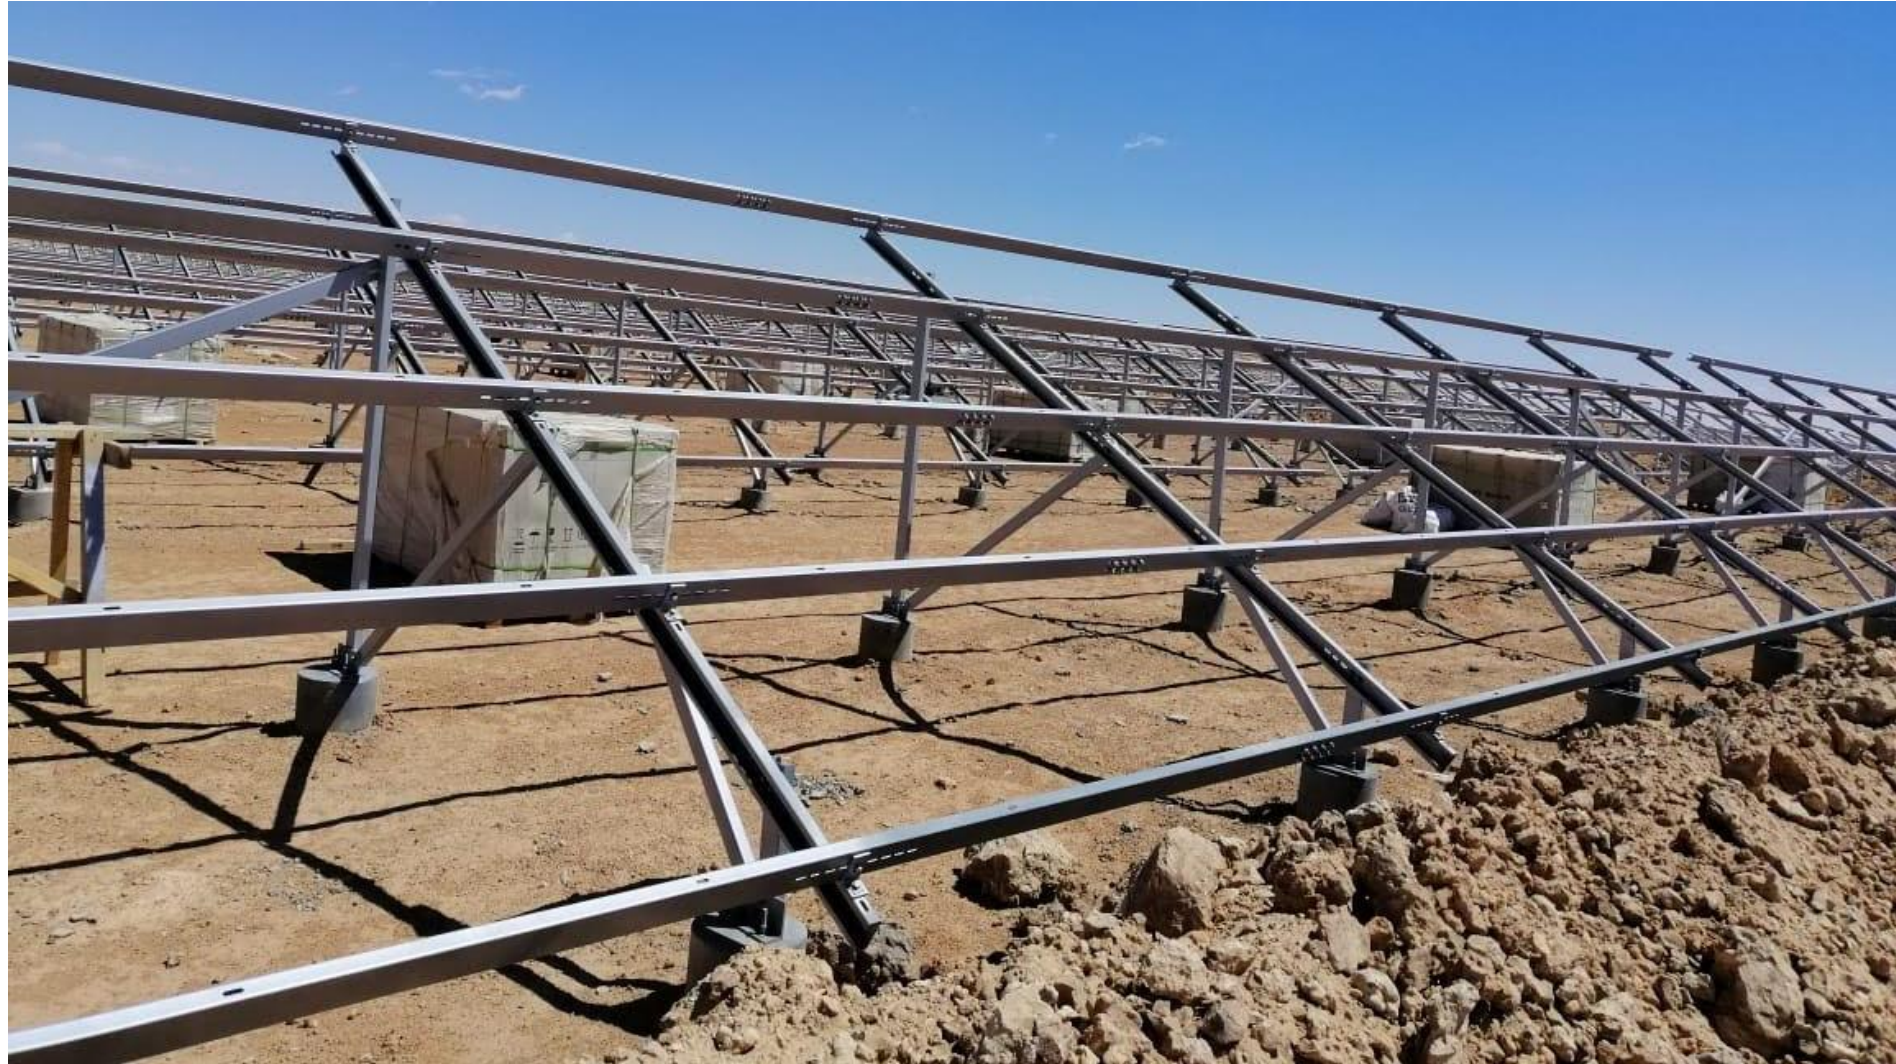
ZINGA APPLICATION AT COVEC

The supports of the solar panels have been hot-dip galvanized. After their installation, anomalies appeared in the form of blackish spots.

Problem: Cross cut test as per ISO 2409 shows that there is not a sufficient adhesion between the ZN + PU system and the galvanized supports

The technical and control office mandated -LPEE Public Laboratory of Tests and Studies- recommended the following solution:

- Brushing of media that present defects

- Application of a paint system of the brand COLORADO:

Primary COLOZINC + Finishing COLOTHANE
