OFFICE TOGOLAIS DES PHOSPHATES PHOSPHATE MINE OFFSHORE CHARGING CRANES - TOGO

Ref.: TG-CN-MA-OL-PE-
Off. Togolais-EN-09/02/07

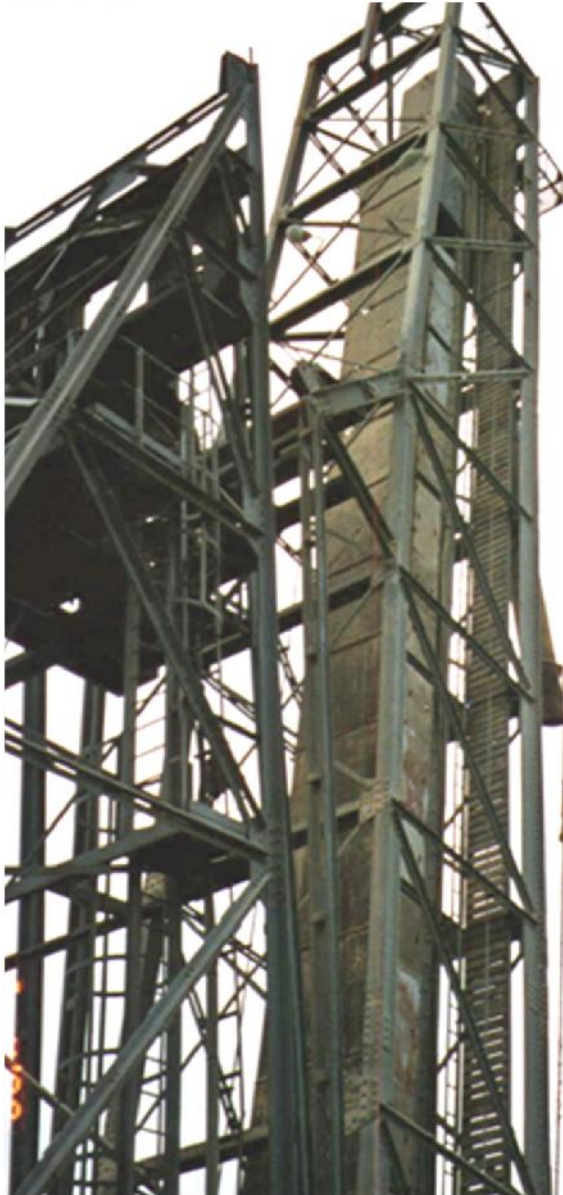
In 1994 the cranes were repaired by the French company Africaine de Montage (Baudin Chateaufneuf). A permanent service and maintenance was obligatory during the repair of the cranes. After grit-blasting, the structures needed to be repaired by welding.

These two cranes and their passing link (the conveyer) were heavily corroded and it was decided that they had to be protected by an anti-corrosion system providing cathodic protection: **ZINGA** was chosen.

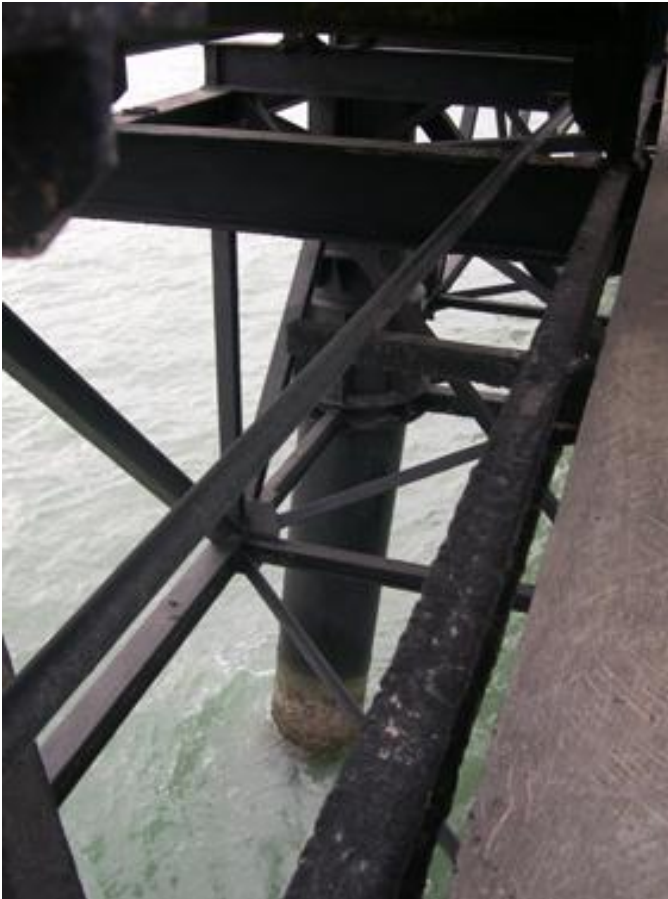
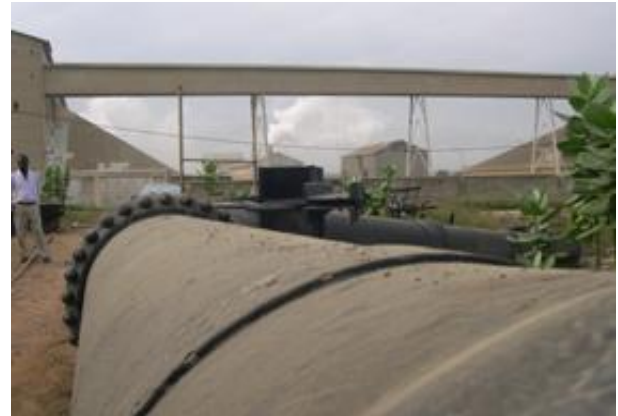
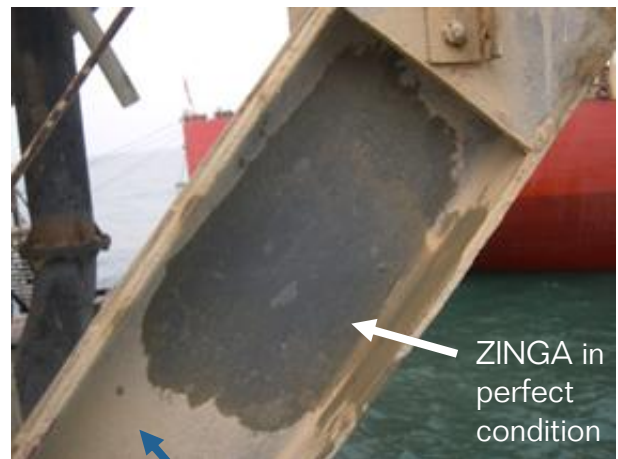
Evaluation inspection 2006 after 11 years!

- At first sight: bad condition
- At close look: phosphate dust & other deposits!
- Adhesion test: excellent
- Overall good condition of ZINGA
- Some local formation of blisters

Phosphate dust

Only some local minor repairs had to be done to remove blisters (due to solvent retention) and rust spots (due to mechanical abrasion and local bad surface preparation). The main contractor was Sogea Satom (Vinci SA).

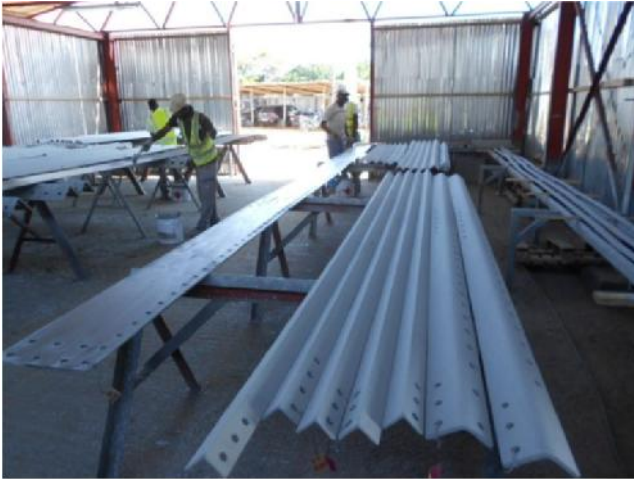
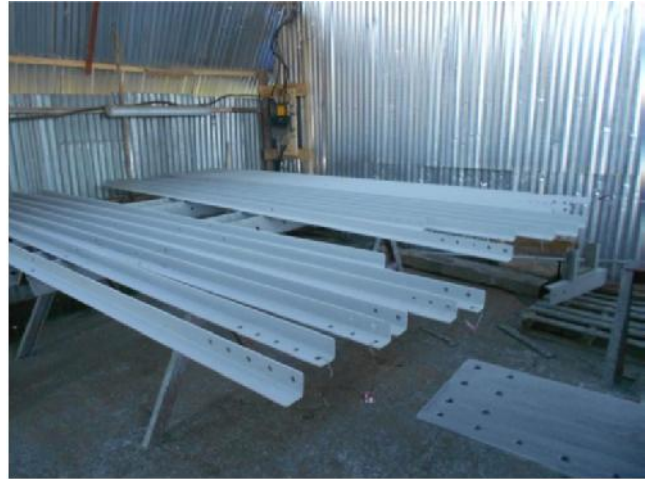
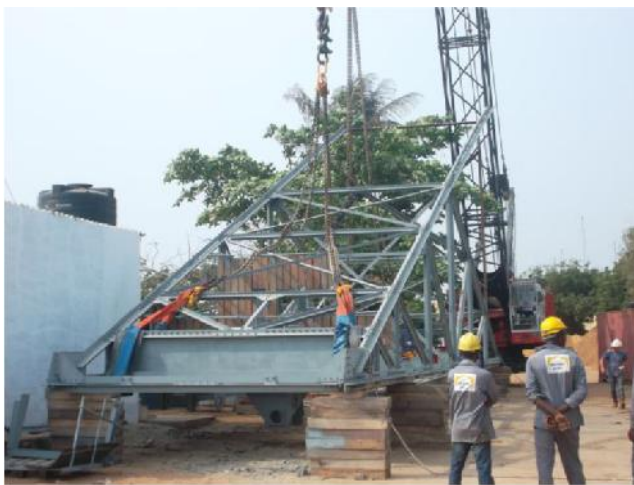
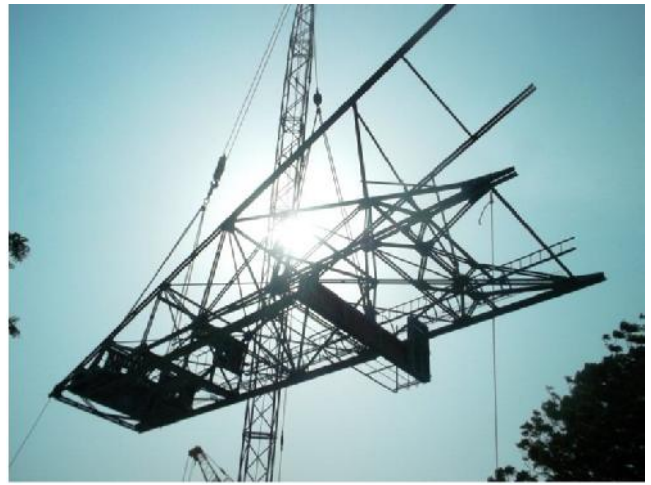
In 2014, the loading arm and pylon was damaged and needed to be replaced.

For this replacement structure, ZINGA was also specified. In the same refurbishment project, a rail transport bridge was also protected with ZINGA.

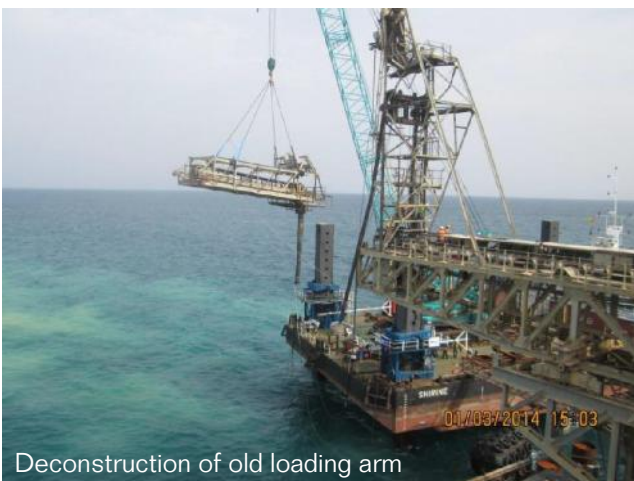
Deconstruction of old loading arm

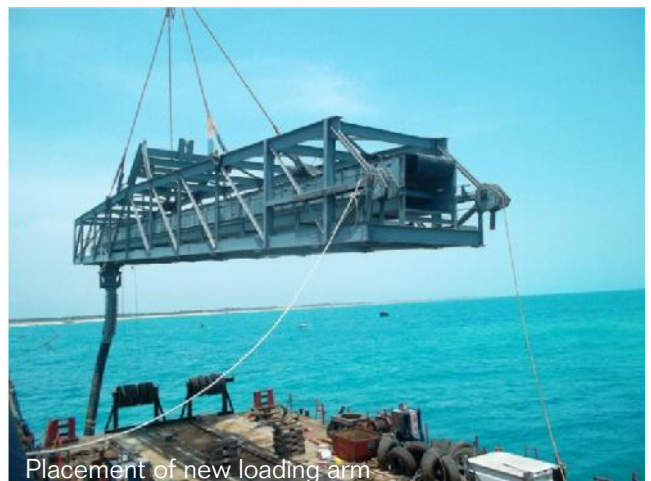
Placement of new loading arm
