Laboratorium, Prinses Elisabethplein 7, 1030 Brussel

**Subject: Adherence of concrete to rebars – differences observed between Zinga coated and other rebars**

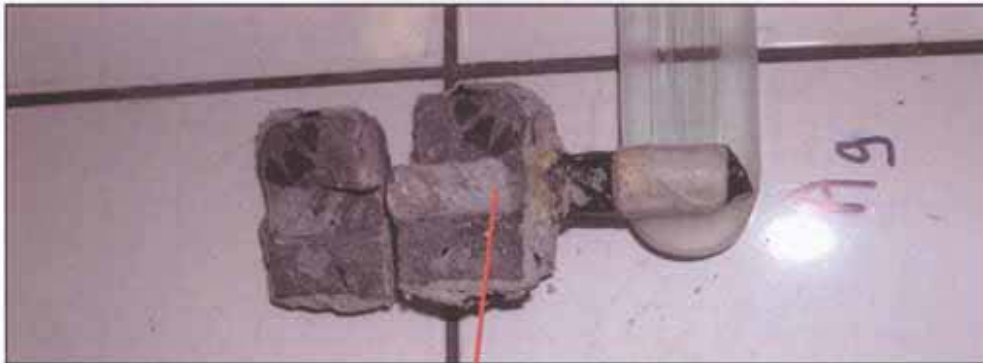
Thin layer of cement and Zinga on steel rod

After cleaving, we noticed the rupture happened in the concrete layer, close to the steel rod. It took more force and cleaving attempts than with the uncoated rebars.

It is clearly more difficult to cleave the rebar bloc containing the steel rod protected by Zinga. The adherence of the concrete to the steel rod is better. The actual cleavage happens in the concrete. See photos on next pages

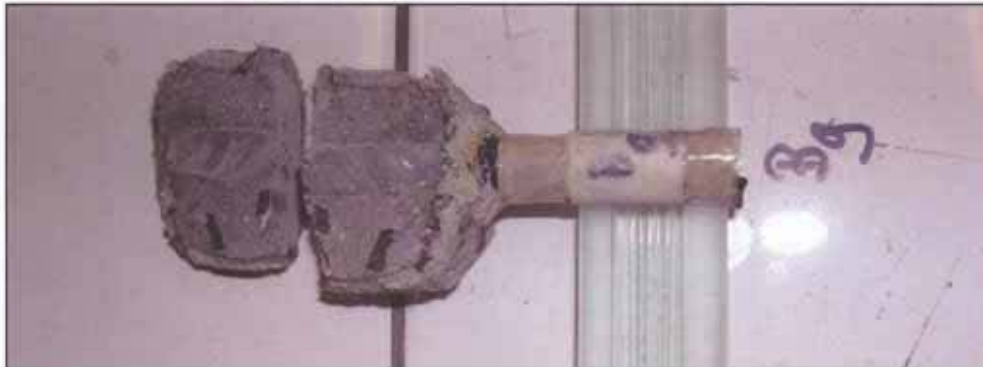
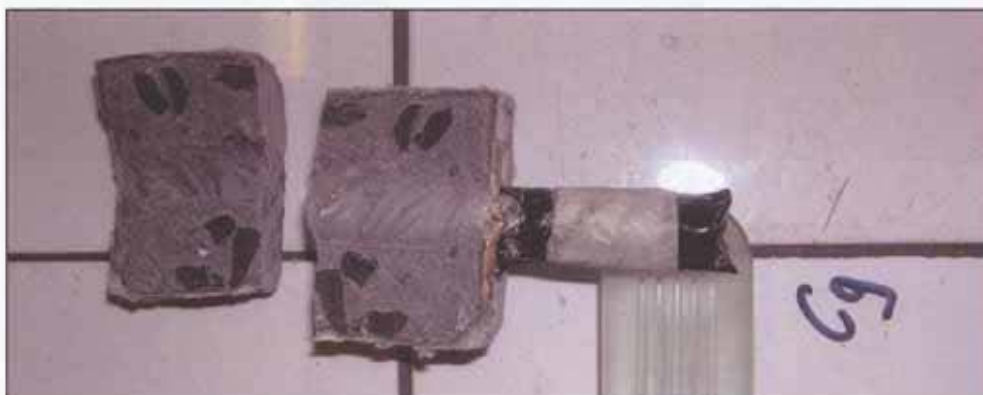
The other two rebars cleaved neatly between steel and concrete, which indicates a weaker adherence. As an adhesives specialist, I can confirm that cleavage between substrates usually indicates a weaker bonding than the internal strength of the substrates, which is generally considered a lesser adherence.
