DANZAS - BELGIUM

Pictures of the application of ZINGA (25 to 40 μm) and Sealer Washprimer on a truck of the brand Scania in January 2001. The proprietor of the truck is the company Danzas. The coating was applied by Saey's.

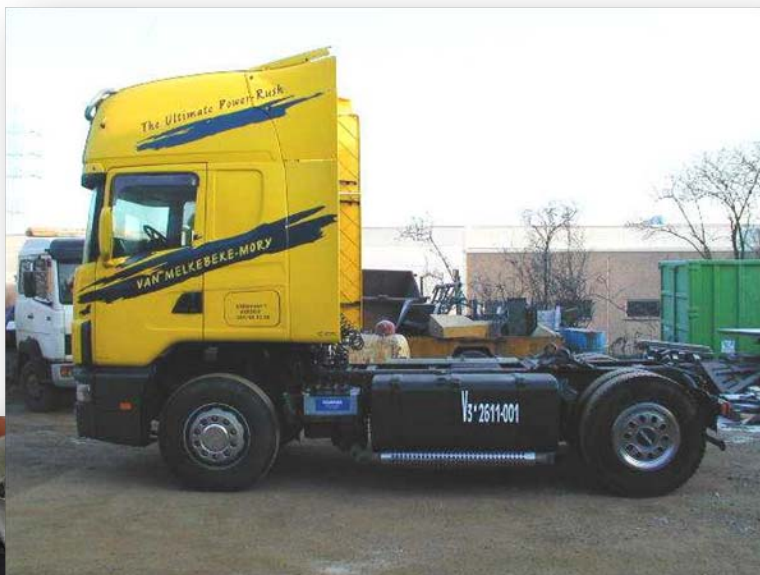
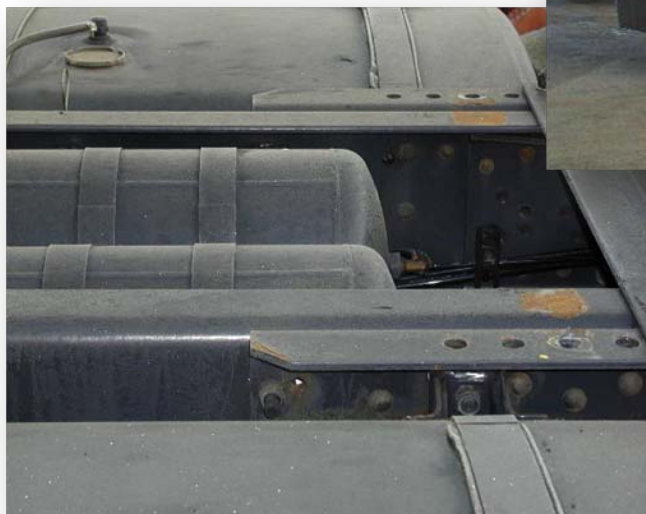
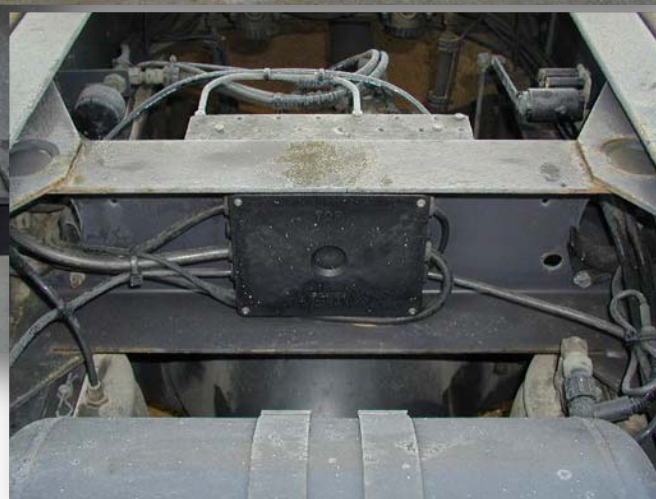
Rust formation on the chassis of the truck.

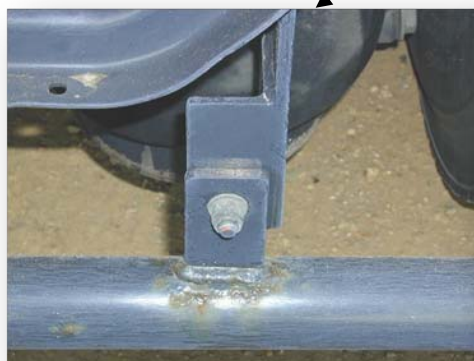
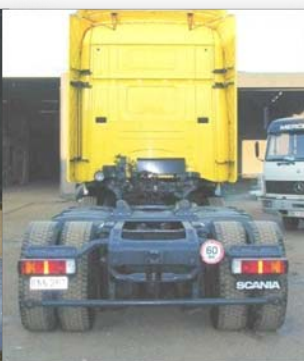
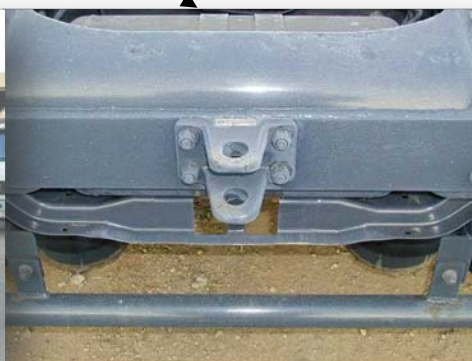
And on the back of the truck.

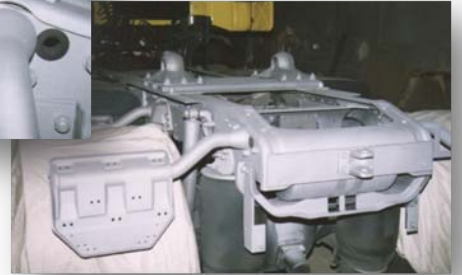
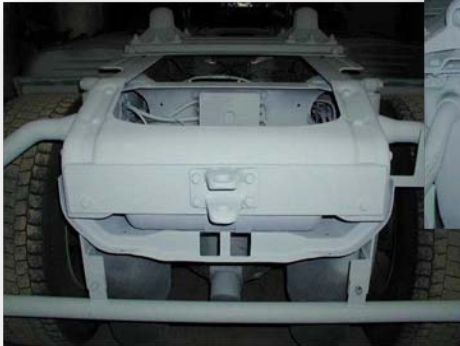
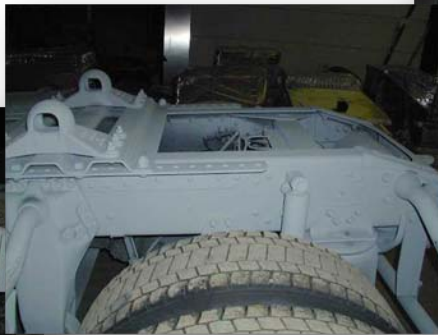
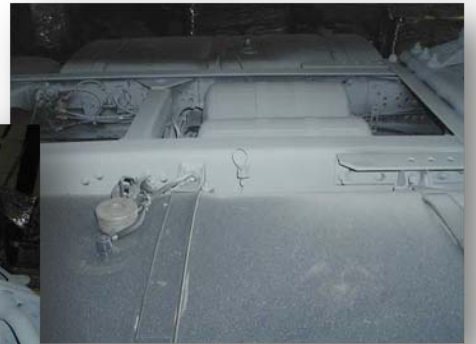
After sandblasting ...

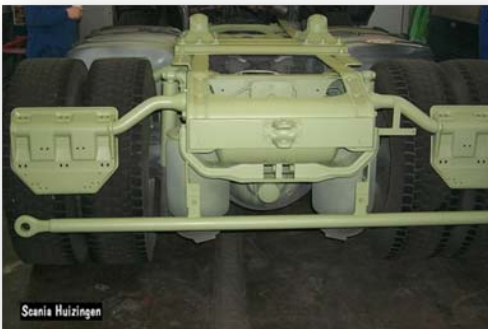
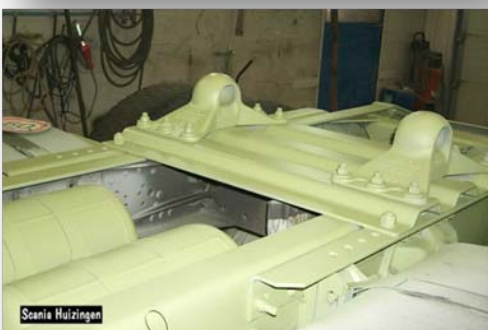
System :

ZINGA 1 x 25 to 40 µm

Followed by a Wash Primer application

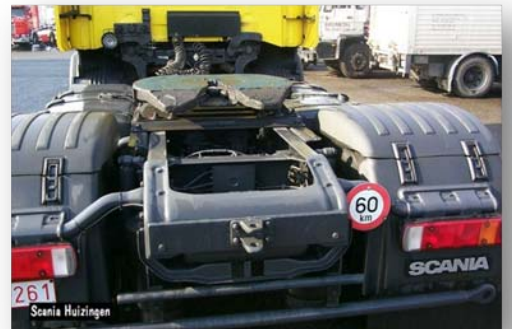
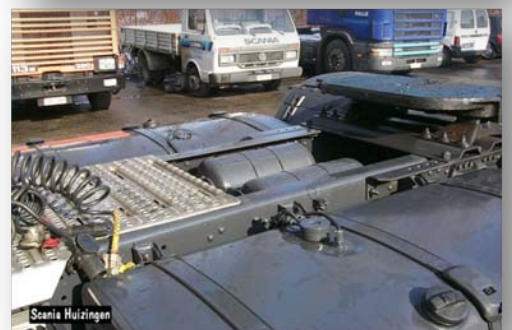
And finalised with a black finish coat
