3. Reference information (specifically Marine environments)

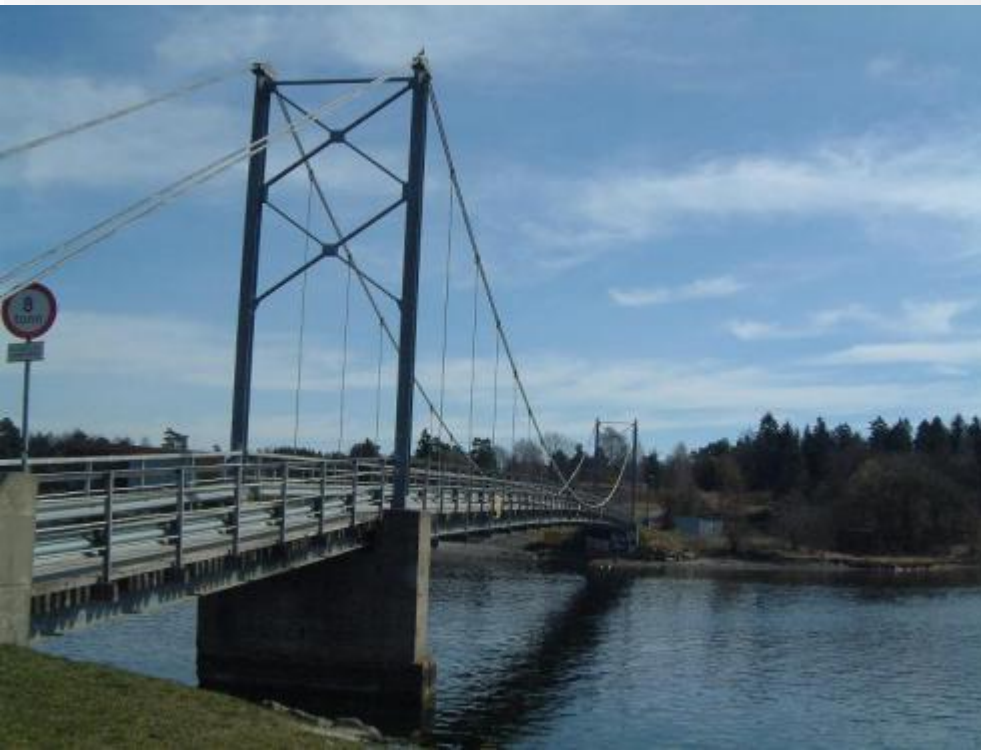
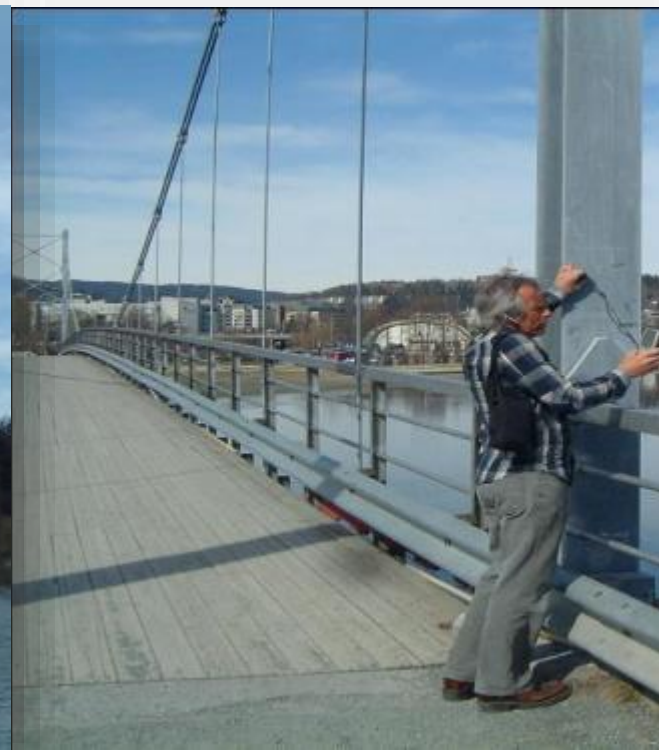
- *Kalvoya Bridge (Norway)*
In 1985
ZINGA 2 x 60 μ m DFT
In 1995 an independent inspection showed no need for repairs.
In 2010 only 30 μ m ZINGA had sacrificed itself to protect the metal underneath
