MÖNSTERÅS RAILWAY BRIDGE - SWEDEN

This railway bridge is located in Mönsterås, in the Southeast of Sweden, 50 meters from the Kalmarsund Sea Strait.

It was built in 1957 and re-coated in 1979 with a traditional 3-layer paint system.

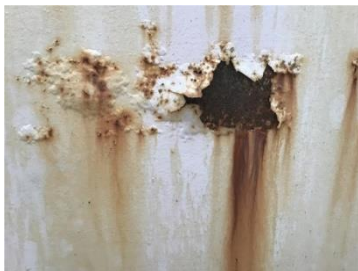
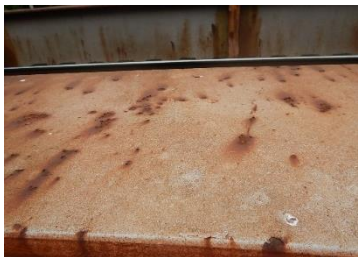
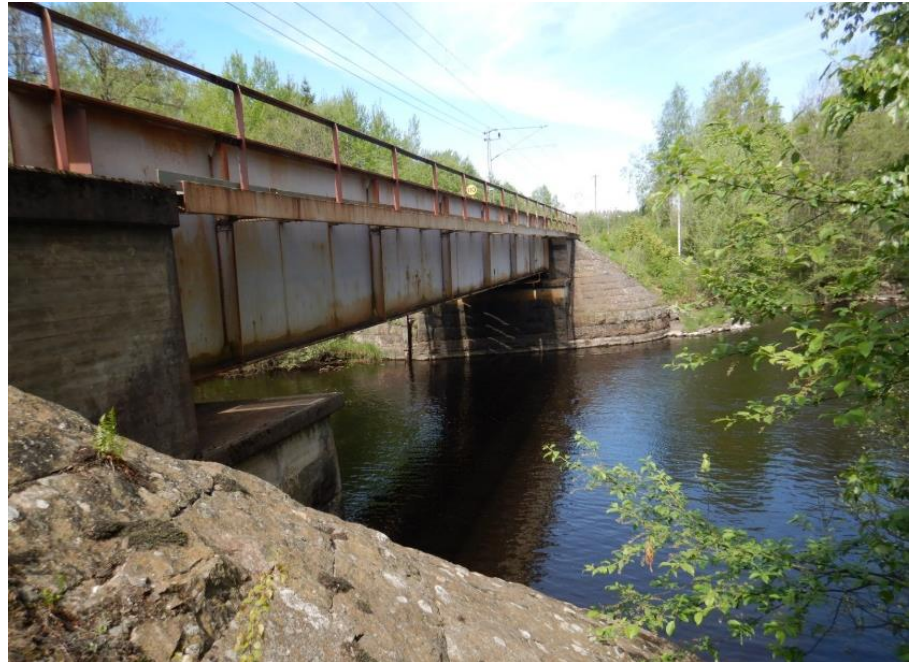
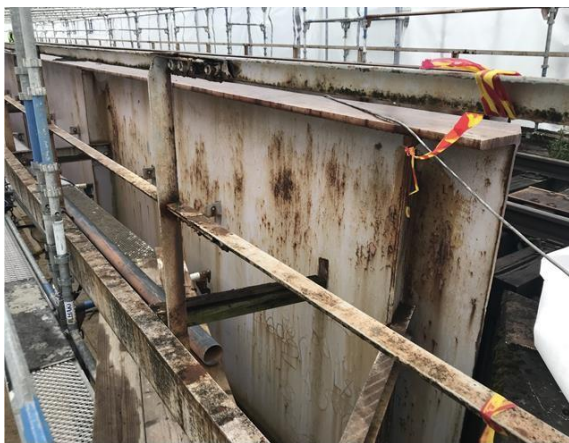
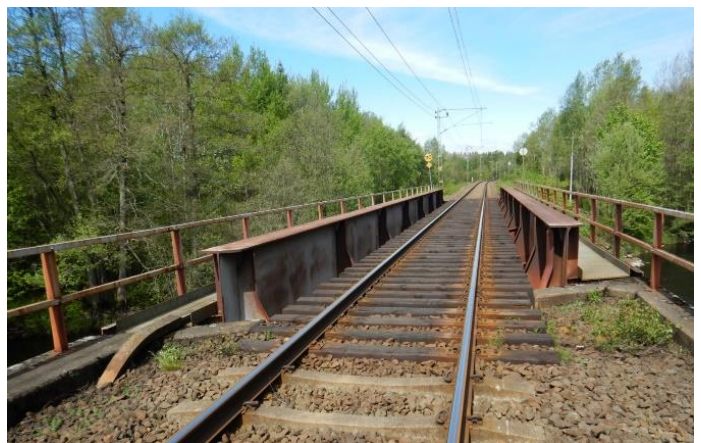
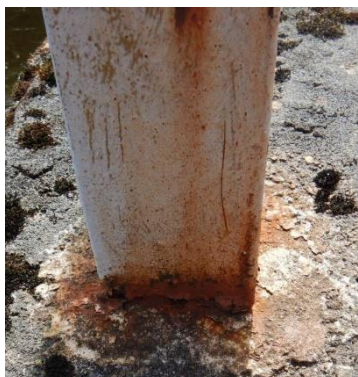
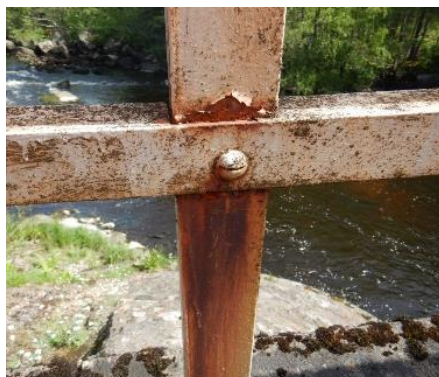
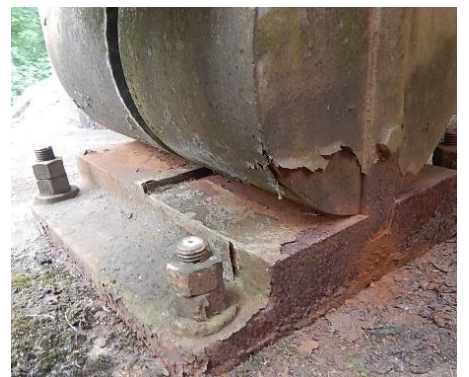
The bridge was in very bad condition as you can see on these pictures.

In the summer of 2020 **TRAFIKVERKET** (Swedish Road Administration) decided to fully repair and recoat this bridge with a **ZINGA** stand-alone system.

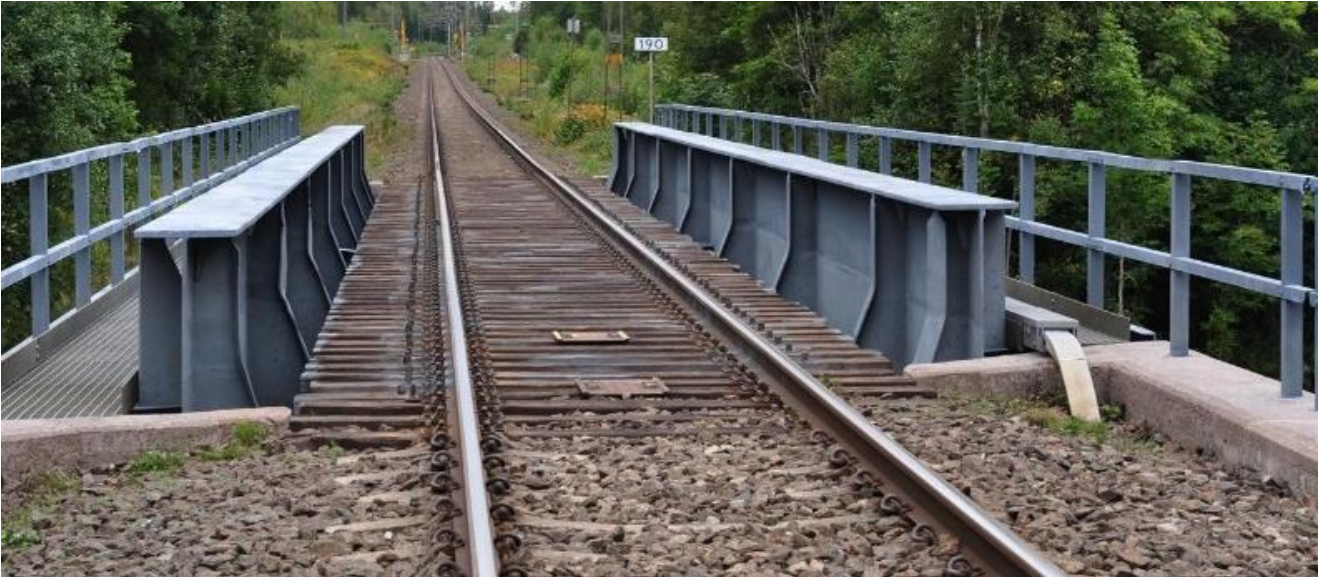
The pictures below were taken in June and in September 2020.

System:
Sandblasting to SA 2,5
ZINGA (airless spray) 2 x 75 µm DFT
