AKOSOMBO DAM - VOLTA RIVER AUTHORITY - GHANA

In 2009 talks started about recoating the exterior of 6 penstocks and cranes (450T; 85T and mobile hoist cranes) that are part of the Akosombo Hydroelectric Project. In 2012 the application on $10,000\text{m}^2$ with the **Zingametall coatings** started following their

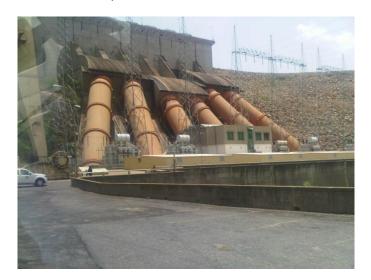
Above: the six penstocks (before **ZINGA** application)
Right: 450 ton crane.

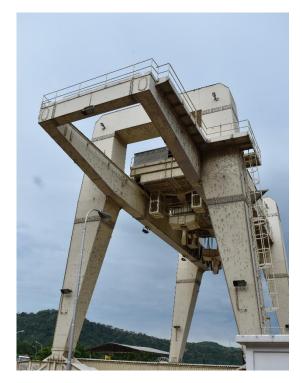
In 2020, **8 years after application**, a visit with a **ZINGA** representative was organized to inspect the state of both the penstocks and the crane at the **AKOSOMBO** Dam. The **ZINGA** system on both structures was in perfect condition and in excellent state.

The color difference on the penstocks is due to a layer of dust on the surface.

The dark spots on the 450 Ton crane legs are webs of local spiders.
