CULVERTS – AUSTRALIA

Under-road galvanised steel culverts are used throughout Australia. Road culverts are designed to allow the flow of water under roads and highways. In most case these culverts have provided excellent service but many exhibit corrosion after a while. ZINGA is used for maintenance, to prevent further deterioration of the galvanised substrate, thus removing the cost to either rebuild or re-sleeve the culvert.

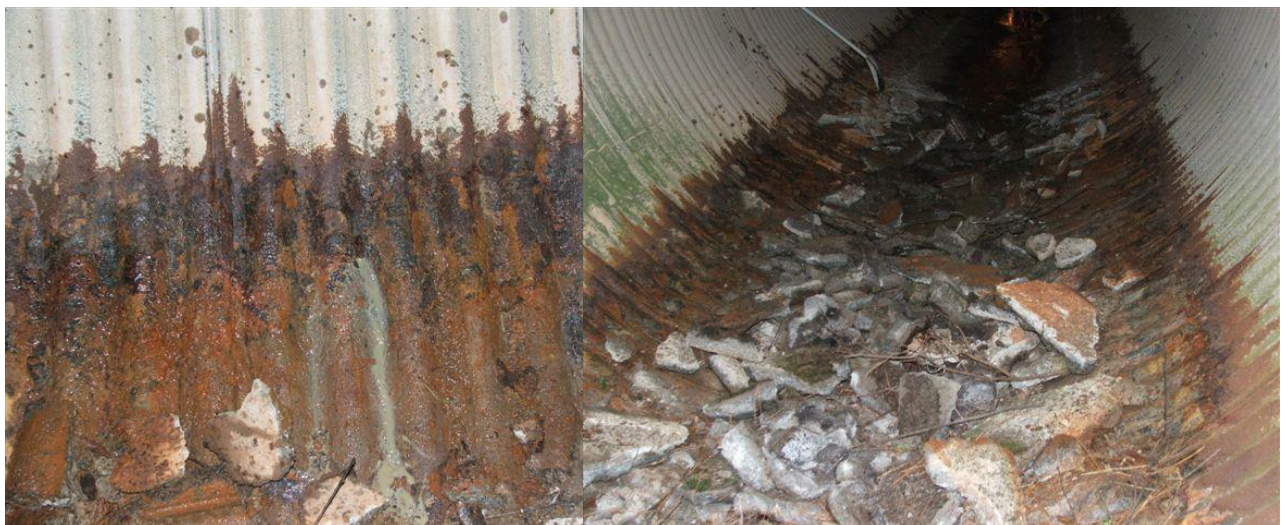
The below pictures reveal the general conditions of the culverts. This is quite common in most states of Australia. As bad as the corrosion looks, in most cases it did not penetrate through the existing galvanized steelwork.

Surface preparation: the surface is simply high pressure water washed to a minimum of 3000 psi at the nozzle head. Chlor*Rid was added at a mixed ratio of 1 part Chlor*Rid to 100 parts fresh potable water.

In 2008, two coats of ZINGA were applied by brush or spray application at 60 µm DFT (105 µm WFT) per coat, having a total dry film thickness of 120 µm. This will result in 30 years extended life of the under-road culverts. Areas with greater than 5% well dispersed pin-point rust were fully blasted to Sa 2½.
