## SANTA RITA BALFOUR BEATTY– PHILIPPINES

In 1999 ZINGA was used to repair old hot-dipped structures at the Santa Rita 1000MW power plant and OHTL (overhead transmission line) ranging from Santa Rita to Calaca (existing coal-fired power plant).

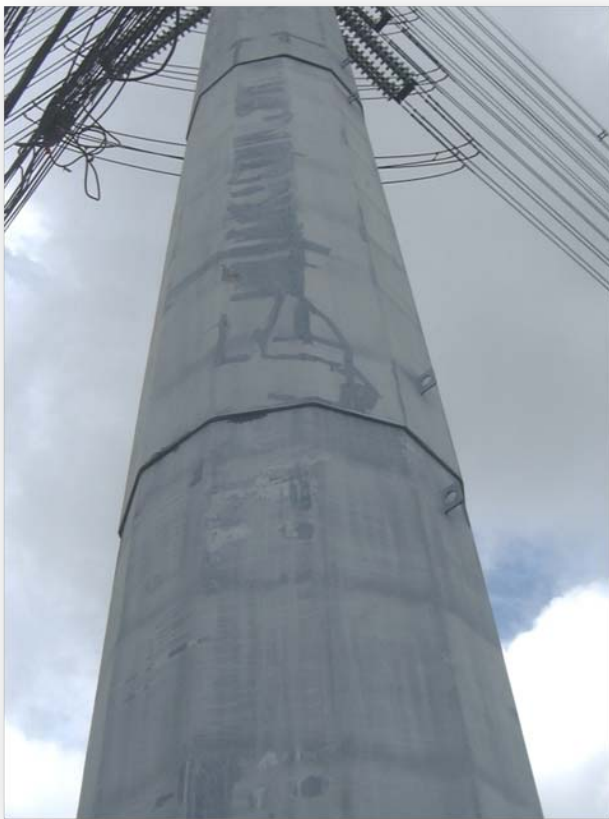
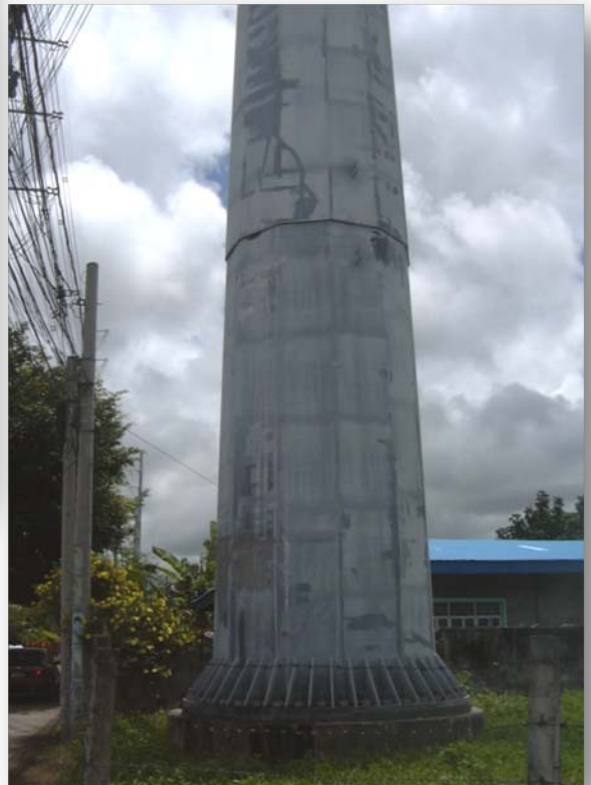
These pictures were taken in 2003, 4 years after the application of ZINGA on old, damaged hot-dip and no rust was detected at all.

Thorough decontamination of old hot-dip

ZINGA      1 x 60µm DFT
